CONSTRUCTION MATERIALS AND TECHNOLOGIES IN THE FIRST NATIONAL ARCHITECTURE MOVEMENT: BRIDGING TRADITION AND MODERNITY

Selin SUR*

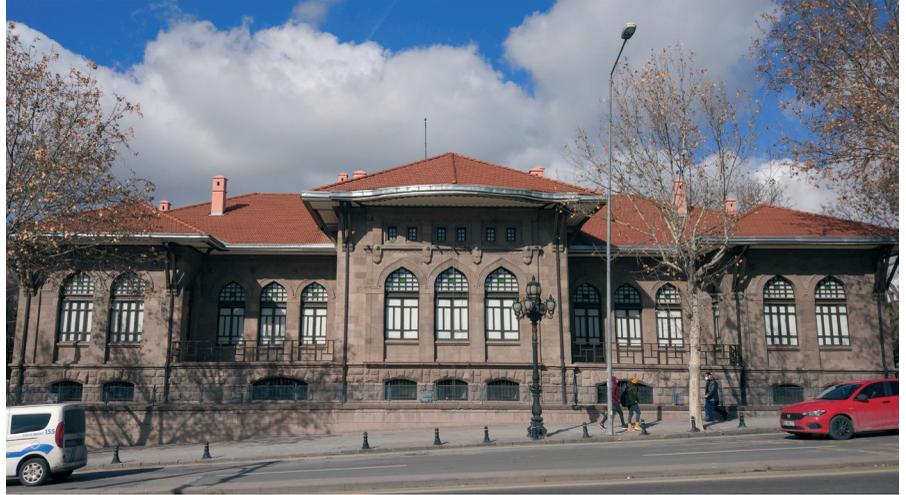
Figure 1. Ankara, The First Parliament of the Republic of Türkiye (Photograph: Selin Sur, 2021)

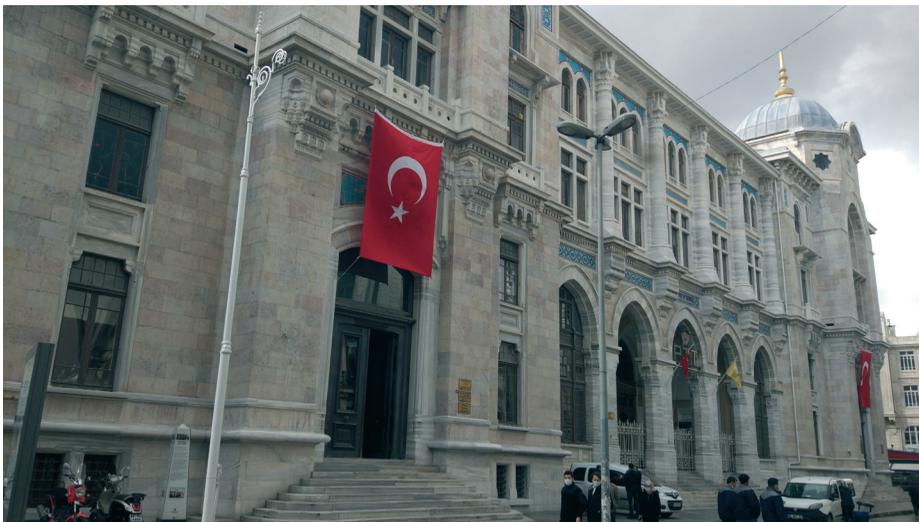
Figure 3. Istanbul, the Grand Post Office (Photograph: Selin Sur, 2021).

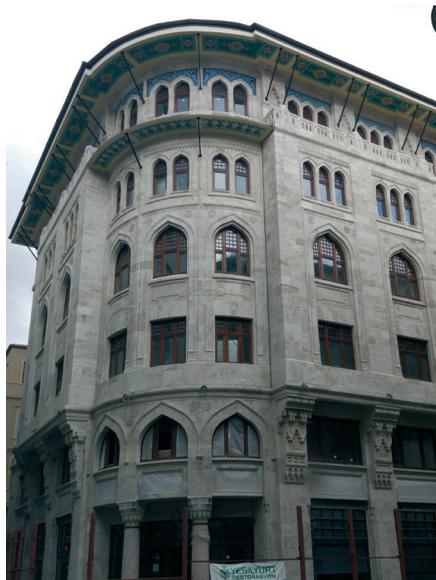
Figure 6. Istanbul, 1st Waqf Han during its restoration (Photograph: Selin Sur, 2021).

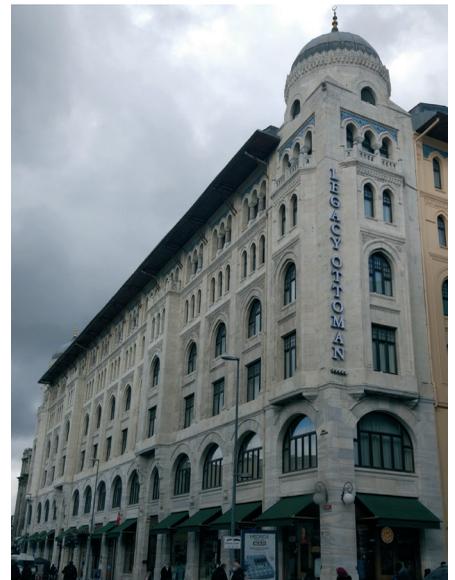
Figure 7. Istanbul, 4th Waqf Han (Photograph: Selin Sur, 2021).

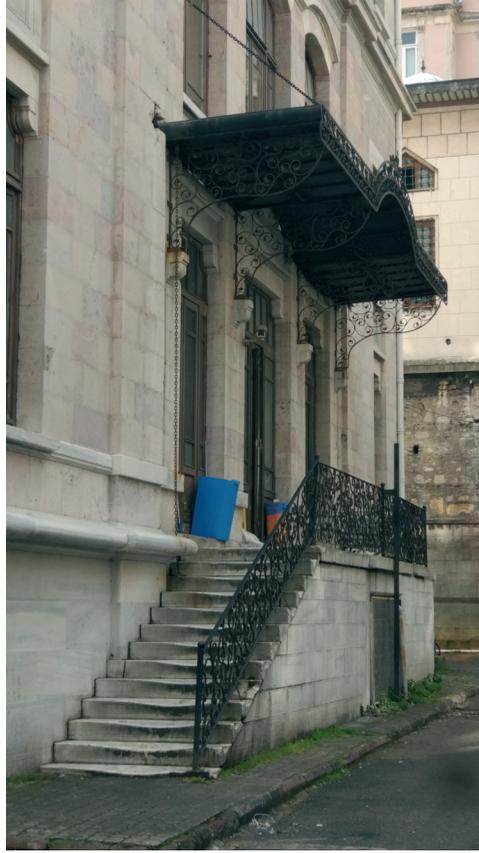
Figure 8. Istanbul, the iron canopy and railings of the Grand Post Office (2021).

Some traditional construction materials evolved during this period and found wider application. For centuries, iron had been used for structural purposes in Ottoman architecture (Tanyeli, 1990). In the 19th century, its applications expanded due to its advantages and the introduction of new architectural buildings and elements (Köksal, 2009). Industrial iron and steel remained imported materials until the establishment of the Turkish Iron and Steel Corporation in 1937. Before local production began, iron was imported from Belgium, England, Italy, the Netherlands, Russia, Sweden, and Norway (Baturayoğlu Yöney, 2008, 101). Wrought and cast iron were used as canopy and glass ceiling structures, buttresses to support the wide eaves, structural frames for building projection floors, bars for windows and doors, railings, and fences (**Figure 8**).

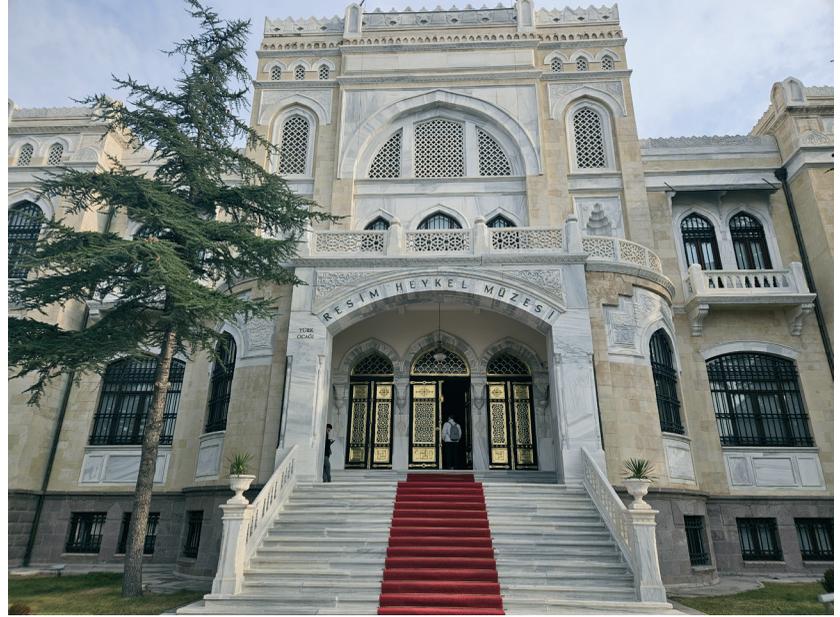
Figure 10. Ankara, the main façade of the Turkish Society Building (Photograph: Selin Sur, 2024).

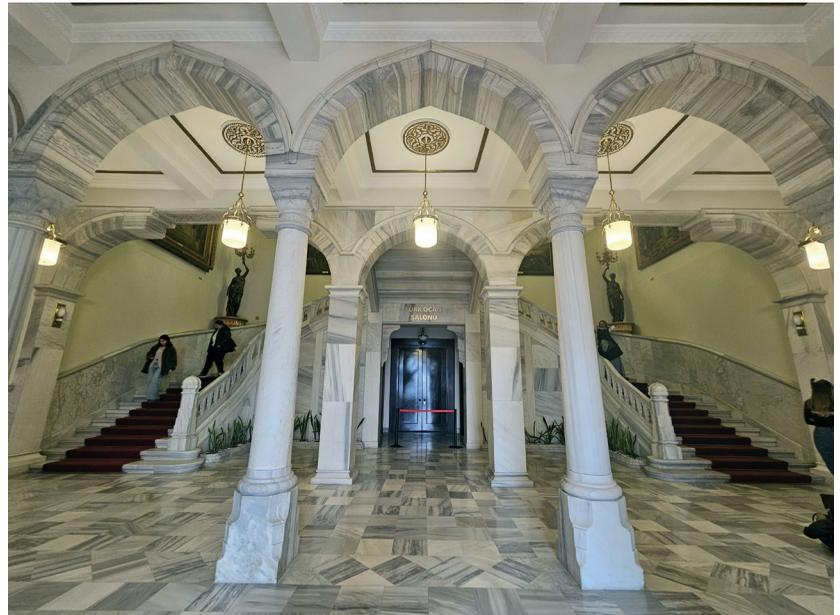
Figure 12. Ankara, the entrance hall of the Turkish Society Building (Photograph: Selin Sur, 2024).

Stone cladding often combined different styles and materials, creating visually rich textures and dynamic effects. Many façades featured a combination of rustic or ashlar masonry with bossed stones on the plinth walls, adding a sense of strength and durability. The upper sections were typically finished in ashlar stonework, with different stone types used to create subtle contrasts and refinement (**Figure 10**). The alternating use of stone allowed for artistic expression, creating bichrome effects by alternating different types of stone in the façade and arched openings (**Figure 11**). A more common approach involved cladding the plinth walls with stone, while the upper portions of the façade were finished with plaster. Stone was also an indispensable material for interiors, particularly in prestigious buildings (**Figure 12**).

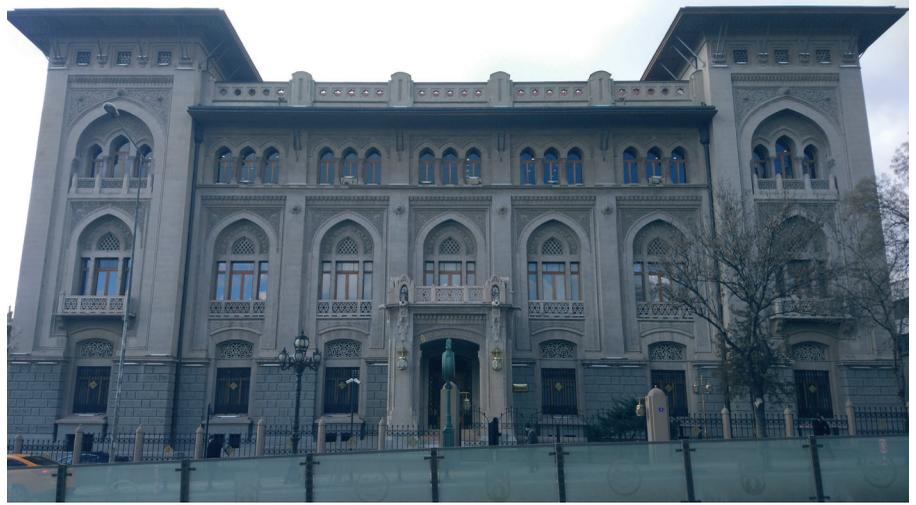
Figure 13. Ankara, the General Directorate of İş Bank (Photograph: Selin Sur, 2021).

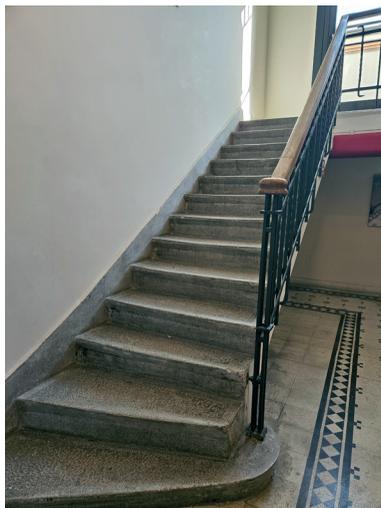
Figure 17. Ankara, the mosaic stairs and floor tiles of the General Directorate of Ziraat Bank (Photograph: Selin Sur, 2024).

flooring materials, such as floor tiles (In Turkish, *karosiman*, derived from French *carreau ciment*), terrazzo tiles, and mosaic (**Figure 17**). At the same time, stone and wood floorings continued to be traditionally used (**Figure 18-19**).

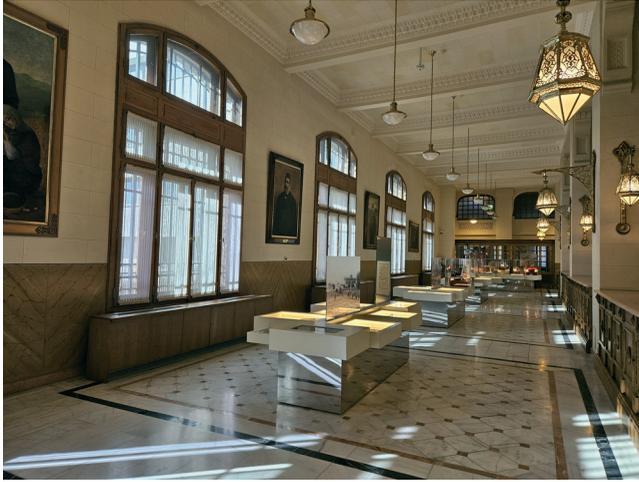
Figure 18. Ankara, stone flooring in the General Directorate of Ziraat Bank (Photograph: Selin Sur, 2024).

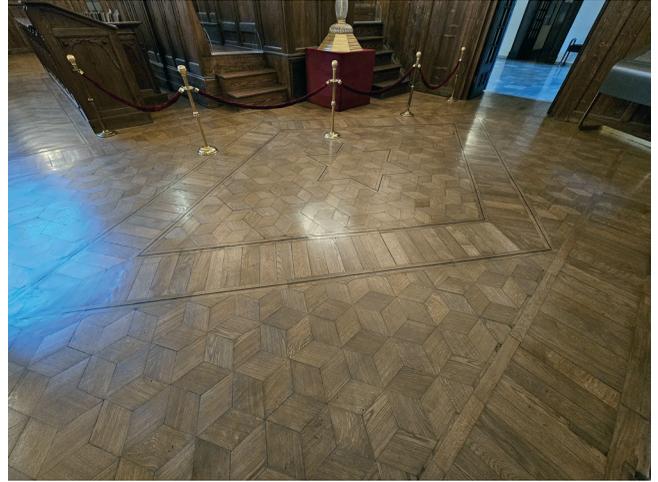
Figure 19. Ankara, wooden flooring in the Second Parliament of the Republic of Türkiye (Photograph: Selin Sur, 2024).

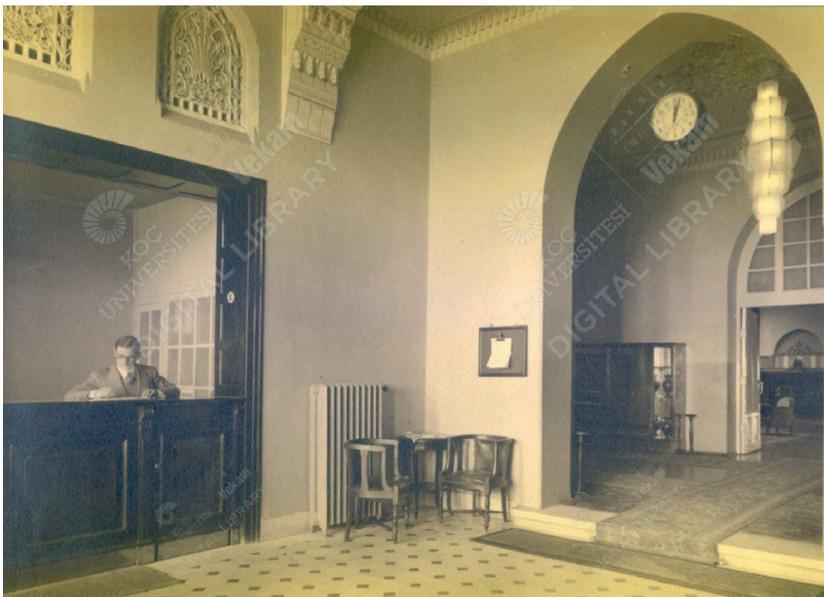
Figure 20. Ankara, revzens and ceiling decorations of the Ankara Palace (Koç University Digital Library, VEKAM Collection, Inventory No: 2598).

Gypsum mortar and plaster were materials that had been used in Ottoman architecture for centuries, and they continued to be employed during the First National Architecture Movement. They were used for interior decoration—on cornices and as column capitals featuring traditional Ottoman motifs such as stalactite or diamond shapes, above doors to give them the appearance of monumental portals, and in the construction of inner windows (*revzen*) (**Figure 20**).

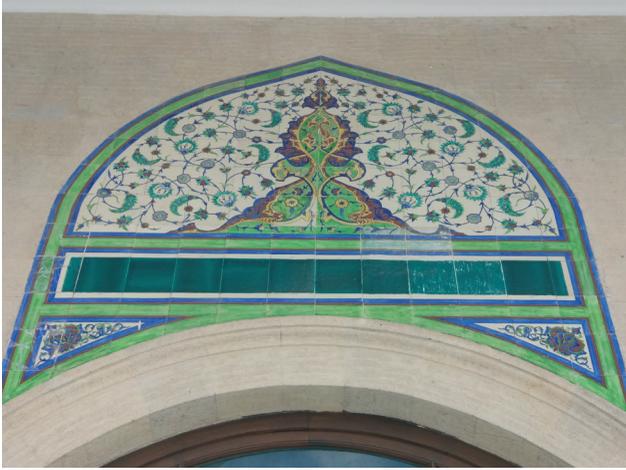
Figure 22. Ankara, the ceramic tiles of the Ethnography Museum (Photograph: Selin Sur, 2021).

in later examples, as the quality of tiles from the Ottoman period far surpassed those produced in the Republican period, in terms of design and craftsmanship (**Figure 22**).

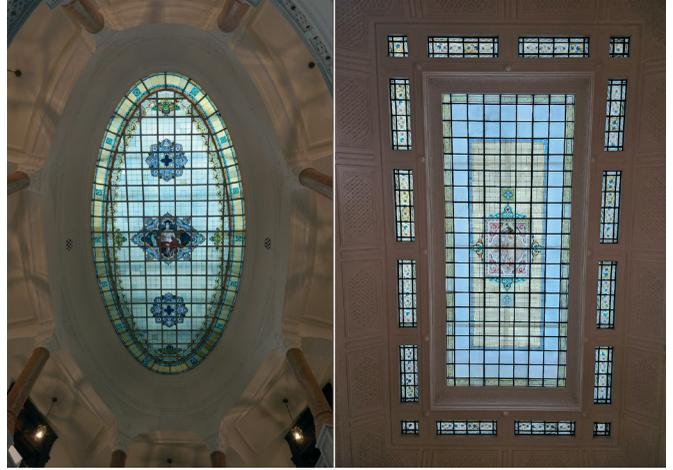
Figure 24. Ankara, the glass canopy of the General Directorate of İş Bank (Photograph: Selin Sur, 2021).

as in the entrance canopy of the General Directorate of İş Bank in Ankara (**Figure 24**).

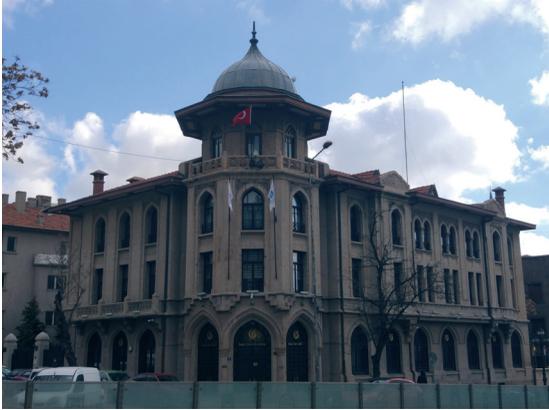
Figure 26. Ankara, the use of roof tiles and lead in the former General Directorate of Monopoly (Photograph: Selin Sur, 2021).

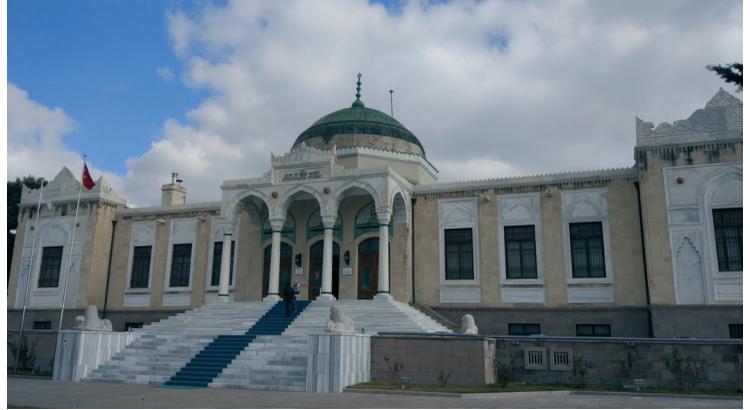
Figure 27. Ankara, the Ethnography Museum (Photograph: Selin Sur, 2021).

rarely used for hip roofs, such as in Haydarpaşa Ferry Pier in Istanbul. The mainstream application for the roofs was covering hip roofs with flat tiles and domes with lead (Figure 26). A unique example is the dome of the Ethnography Museum in Ankara, notable for its tricolor design, which is predominantly covered with what appears to be copper (Figure 27).

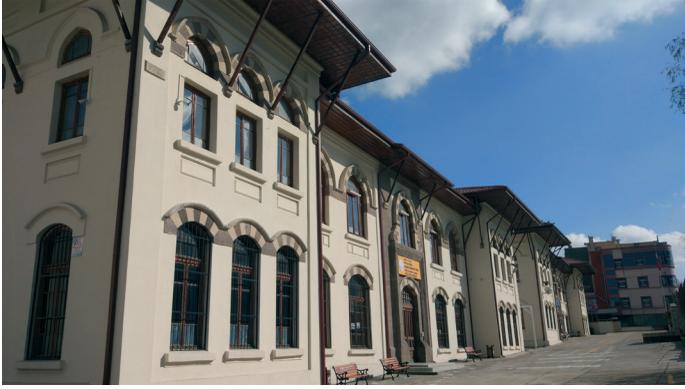
Figure 30. Ankara, present state of the former Gazi and Latife Model Schools (2021).

These discrepancies highlight the need for meticulous examination of buildings from this period, where both traditional and modern technologies and materials were commonly used together. Relying on limited research and superficial observations and, perhaps, the unawareness of the period's materials and technologies has perpetuated misinformation in scholarly literature and has likely contributed to the loss of original architectural characteristics during restoration efforts. To preserve the integrity of these structures, it is crucial to approach them with a scrutinizing perspective and evaluate them using a holistic methodology, looking beyond their appearances. This includes incorporating state-of-the-art imaging systems to analyze structural systems and cross-referencing archival data before any intervention. Avoiding standardized and careless restoration practices is essential to ensure these buildings are rightfully preserved and passed on to future generations.

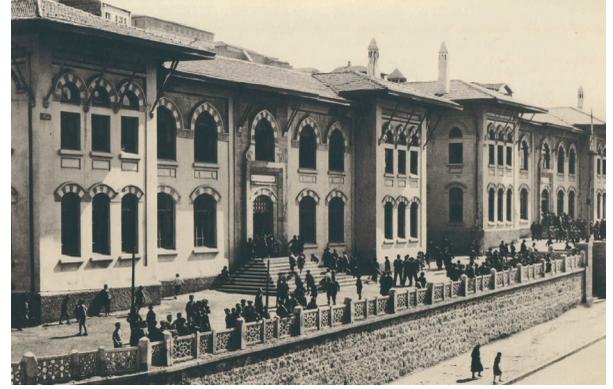
Figure 31. Ankara, former state of the former Gazi and Latife Model Schools (Kültür Envanteri, no: 19817).
