## CONSERVATION ISSUES IN A MULTI-LAYERED HISTORIC URBAN LANDSCAPE: CİLİMBOZ VALLEY, BURSA (1)

Sermin ÇAKICI ALP\*

**Keywords:** Watercourse; historic urban landscape (HUL); multi-layeredness; holistic conservation; stream rehabilitation.

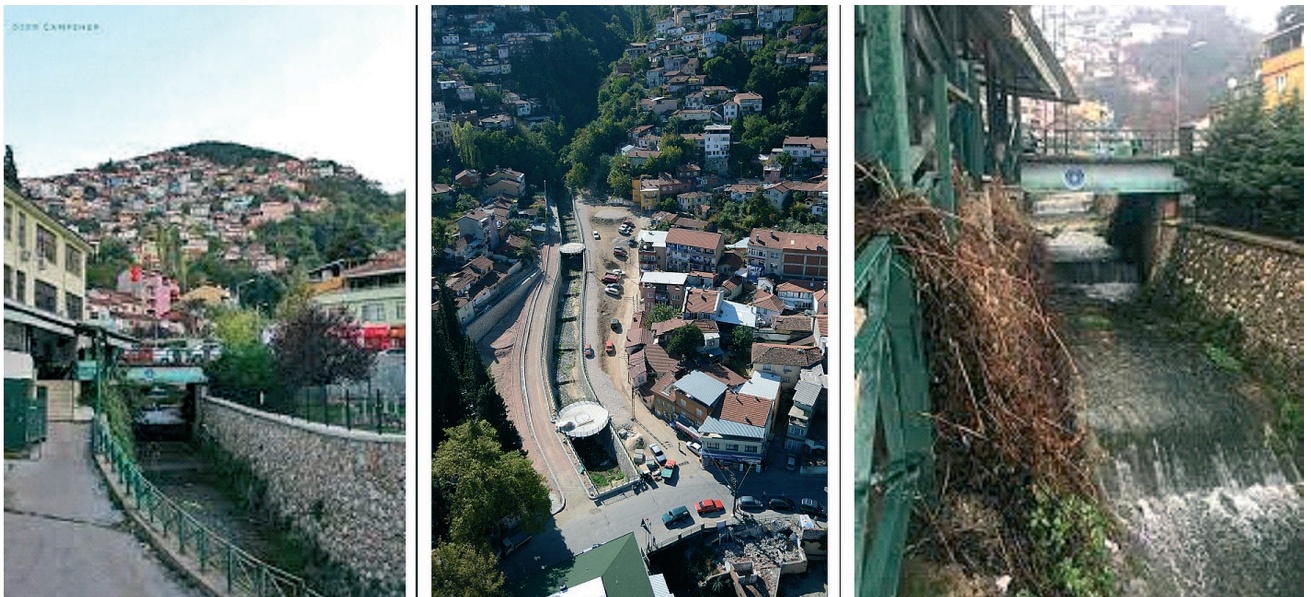
**Figure 1.** The study area along Cilimboz Creek (Bursa Metropolitan Municipality, 2024).

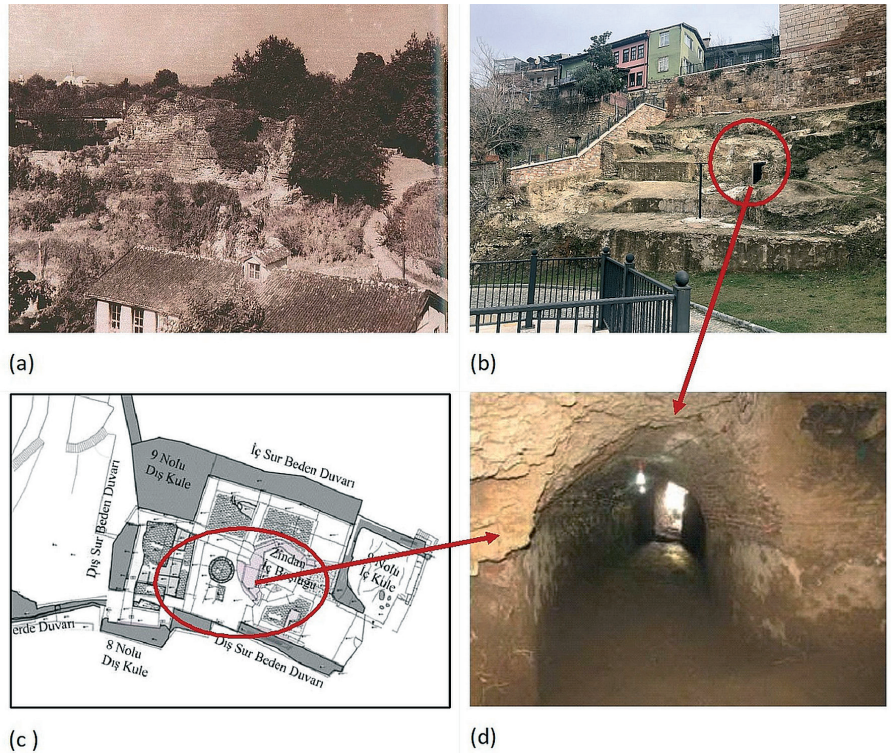
**Figure 4.** (a) Before the excavations around Zindan Gate (Archive of Bursa Metropolitan Municipality), (b) After the excavations around the Zindan Gate (Photo by S. Çakıcı Alp), (c) the documentary plan drawing (Yılmaz, 2007), (d) the interior photograph of the tunnel (Yılmaz, 2007).

walls on the east side of the travertine rock slope (**Figures 4a and 4b**). The tower's outer shell stones and the walls of the Zindankapı (Dungeon Gate) section are still visible, embedded in the hill's massive travertines. According to Yılmaz (2007); the Citadel conceals a tunnel-shaped cellar with a brick-vaulted ceiling measuring 3 meters in width and 2.75 meters in height, which was used to transport supplies from the streambed (**Figures 4c and 4d**). This watercourse continued to supply clean water to residents until the late 19th century, and according to various sources, the natural

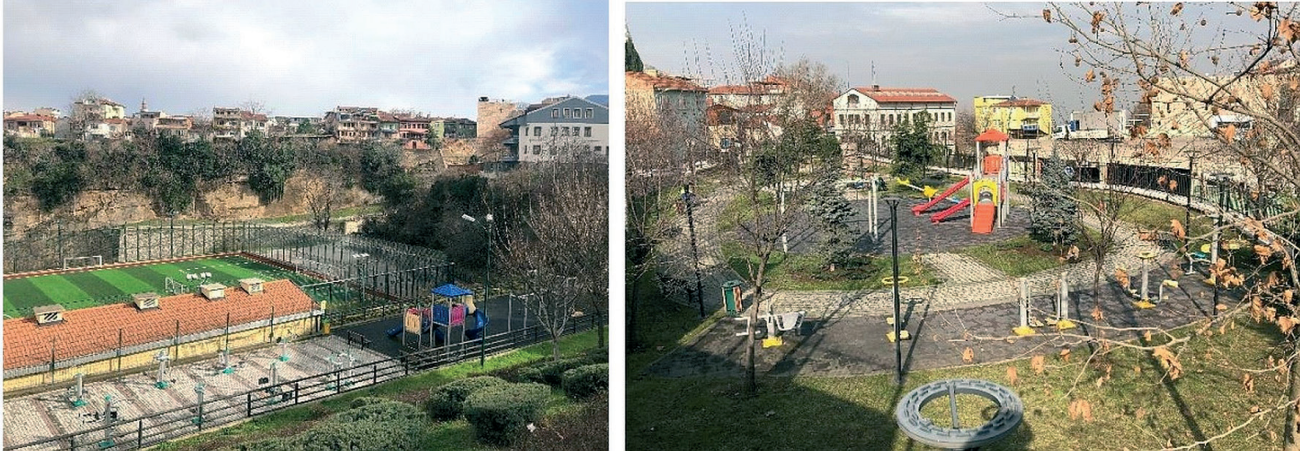
**Figure 7.** The sport center and children's playground applications within the concept of The Alacahırka Sports and Recreation Area Land Use Project (Photos by S. Çakıcı Alp).

2. The Alacahurka Sports and Recreation Area Land Use Project was led by Osmangazi Municipality and concerned with repairing two canals feeding into Cilimboz Creek in 2003. Due to flood risk, green spaces were redesigned for playgrounds and sports facilities, while the traditional texture, including historic bridges, silk factories, fountains, and trees, was conserved through the restoration implementations (Figure 7)

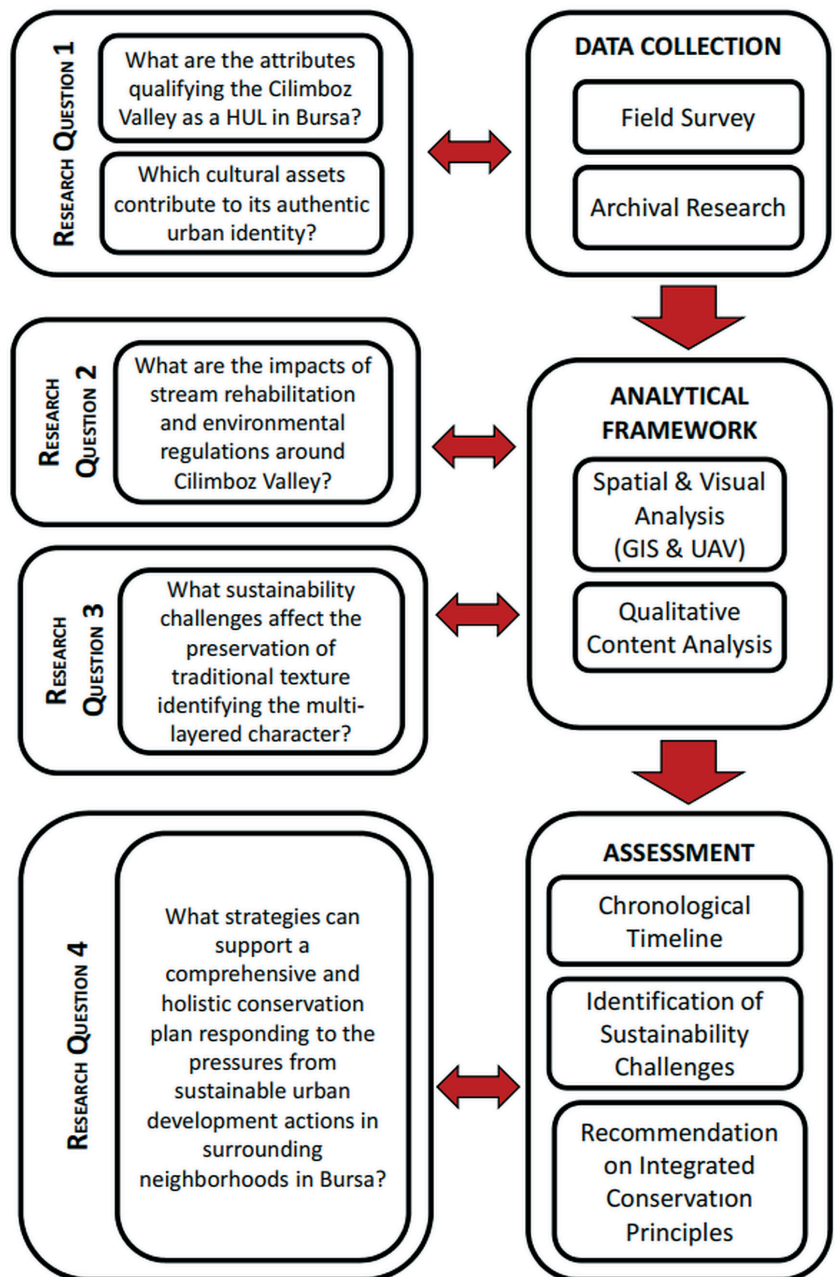
Figure 8. The flowchart revealing the methodological framework in relation to phases of the research.

(Martini, 2012; Çağaptay, 2014; Verdini et al., 2016; Su et al., 2024), the methodological framework progresses through four interrelated phases (Figure 8), which illustrate the process from data gathering to the strategic outcomes:

Phase 1: Historical–Archival Documentation

The first phase focuses on identifying the defining characteristics of the area as a HUL. Primary and secondary sources—such as historical maps, cadastral plans, old photographs, and conservation reports—were collected from local and national archives (8). These materials were analysed to trace the evolution of the built environment and water systems, providing the basis for identifying key architectural and landscape typologies that illustrate the area’s authenticity and integrity.

### Phase 2: Field Survey and Data Collection

On-site surveys were conducted to document the current state of heritage assets, land use patterns, and environmental characteristics such as topography, drainage, and circulation systems. Field observations were systematically recorded through photographs, mapping, and structured checklists. These findings were cross-verified with archival sources to ensure data consistency and reliability.

### Phase 3: Spatial and Visual Analysis (GIS and UAV)

Using Geographic Information Systems (GIS), spatial data from the field and archives were integrated to visualize patterns of transformation and conservation across time (Çakıcı Alp and Şahin Güçhan, 2017; Morandotti and Doria, 2023). Conservation decisions issued by the Regional Conservation Council of Bursa (RCCB) were digitized and layered over spatial datasets to analyse the relationship between regulatory actions and heritage transformations. Complementary low-altitude imagery obtained through unmanned aerial vehicles (UAVs) provided up-to-date visual data to assess physical integrity and recent alterations. By means of this process, it was expected to construct a coherent timeline revealing the interaction between stream rehabilitation, urban development, and conservation attempts.

### Phase 4: Assessment and Strategy Development

The evaluative phase involved a qualitative content analysis of all spatial, archival, and visual materials. Patterns of change, conservation interventions, and urban pressures were synthesized into a chronological timeline. Researchers emphasized the need for strategic approaches to address sustainability challenges, calling for comprehensive conservation and renovation initiatives that would shape the historic urban identity of a landscape (Ahern, 2013; Bandarin and Van Oers, 2014; Zhou et al., 2019; Bohnet et al., 2022). Hence, key sustainability challenges were identified and mapped against heritage values to determine risk zones and areas of opportunity. The findings were then interpreted through the lens of HUL principles—contextual integrity, layering, and continuity—to formulate integrated conservation strategies and planning recommendations for sustaining the historic urban character of the Cilimboz Valley.

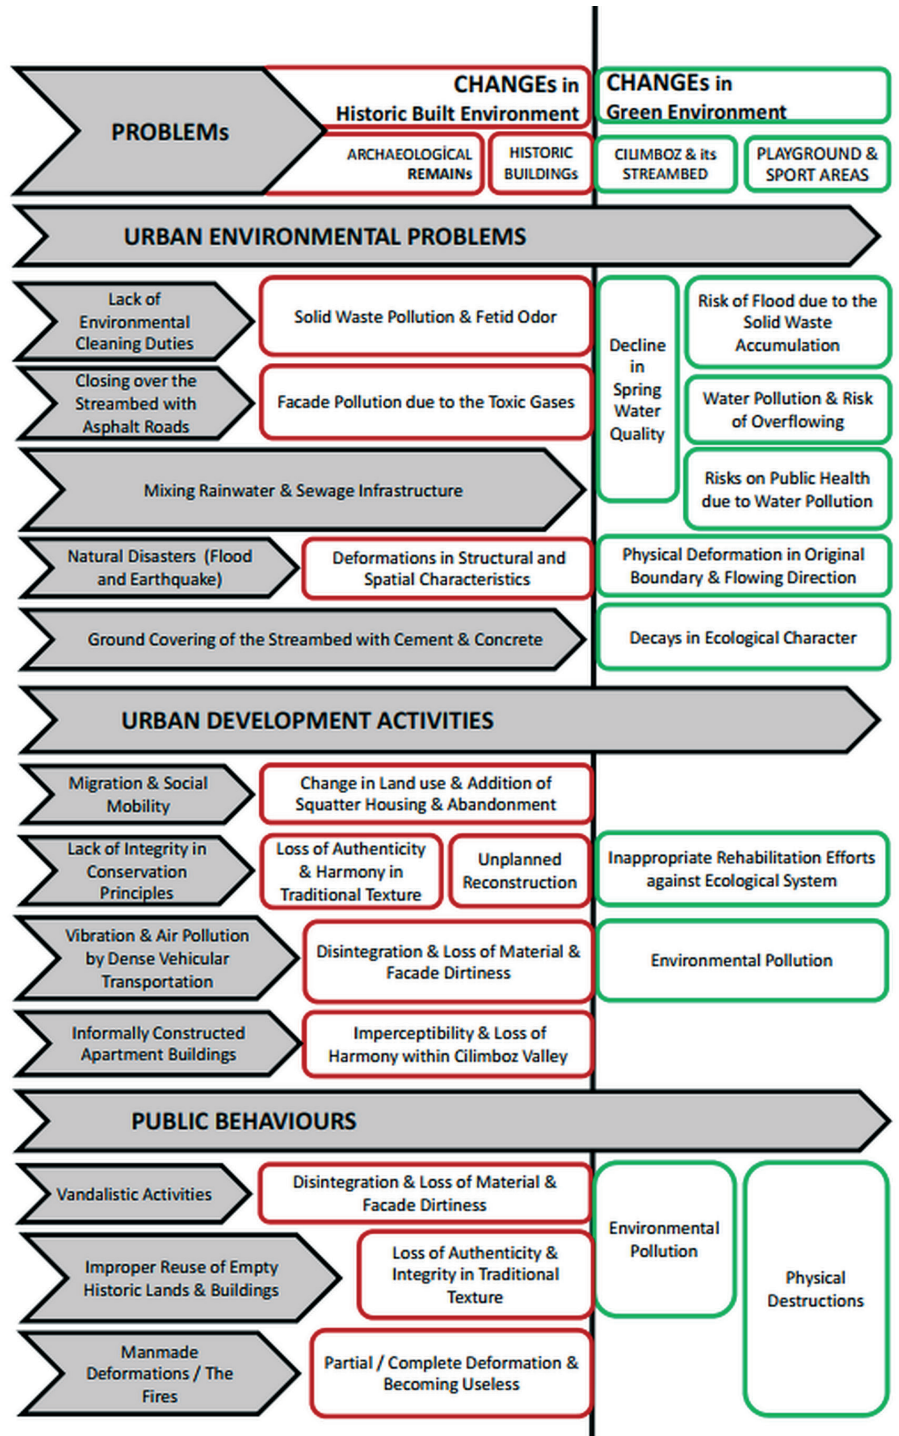
Figure 10. The relation between problems and changes as the results in both the green and historic built environment within the study area.

The ecosystem surrounding Bursa's urban streams, including Cilimboz Creek, faces serious threats from industrialization, unplanned urban development, and rapid population growth, disrupting the ecological and spatial integrity of the area, driving major alterations in the HUL of Cilimboz Valley (**Figure 10**).

and human interventions have caused permanent changes in the physical and social structure of the study area's traditional texture (**Figure 10**). The absence of risk management and integrated maintenance plans has further exacerbated the transformation of the architectural and urban character of the study area (Çahantimur and Öztürk, 2021).

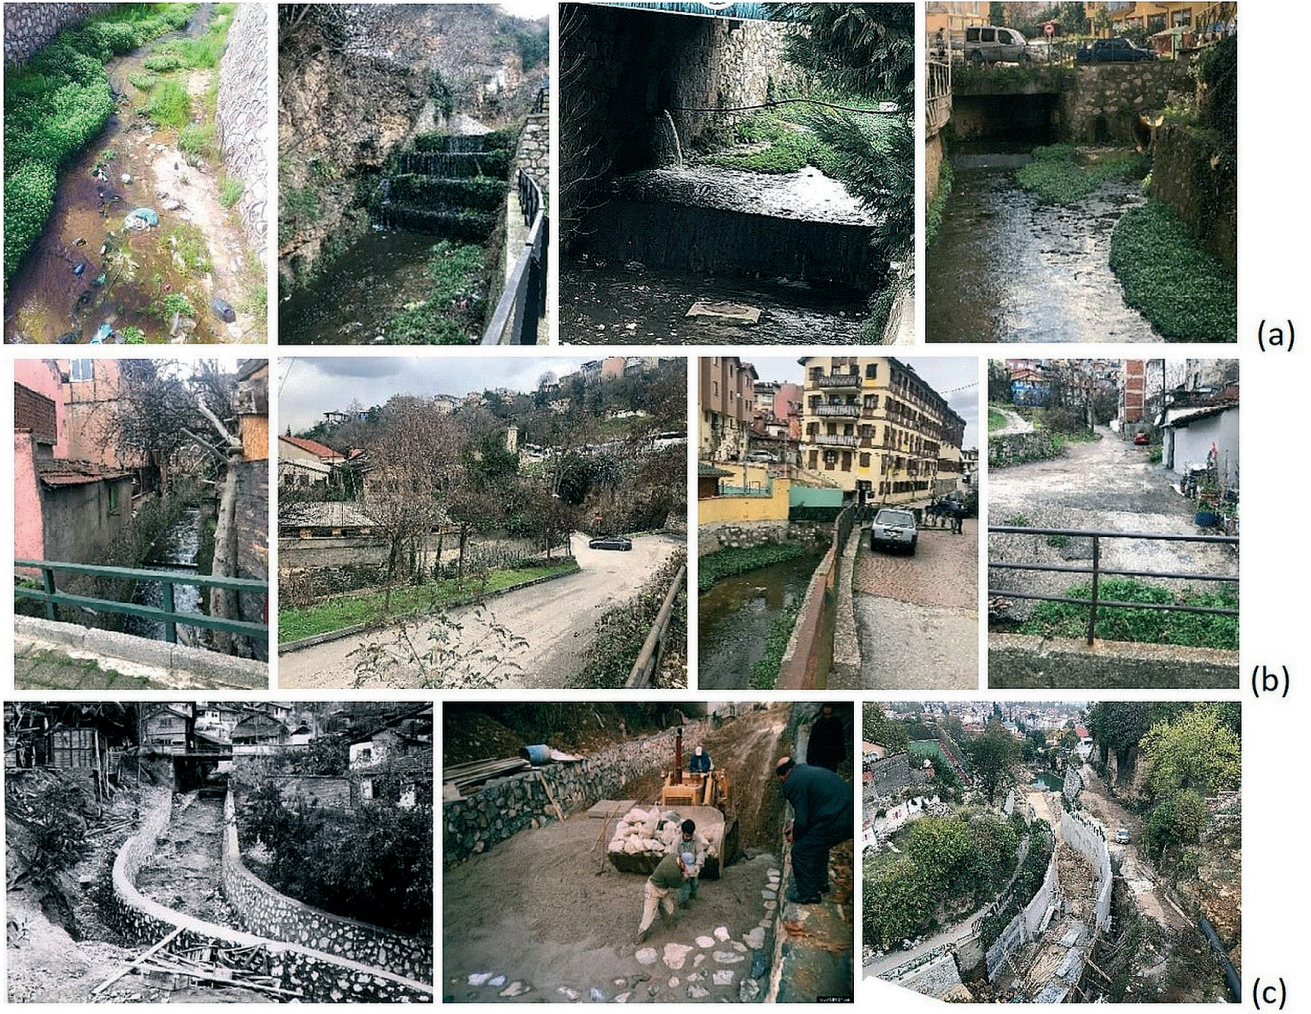
**Figure 11.** (a) Solid waste and water pollution within the Cilimboz streambed (b) Vehicular transportation along Cilimboz Creek, (Photos of (a) and (b) by S. Çakıcı Alp) (c) Process of ground covering with concrete and stone masonry (Photos of (c) from the archive of the State Hydraulic Works (DSİ) and Bursa City Museum).

1980s. According to Çalışkan and Akbulak (2010), its water quality has further declined due to a mass migration and rising housing demand, mostly resulting in the explosion of potentially hazardous construction and squatting around this watercourse. In response, a 1993 sewage project proposed to separate rainwater from wastewater and transfer them into the tributaries of this stream through distinct systems (Figure 11a). Nevertheless, as one of these tributaries, the streambed of Cilimboz could not be prevented from solid waste pollution due to the lack of risk management measures in urban design and rehabilitation efforts. Sewage from historic silk factories caused overflows, leading to environmental waste and foul odours. Untreated wastewater flowed between houses and factories, prompting complaints from residents. Between 1982 and 1984, the Bank of Provinces (*İller Bankası*) developed two wastewater treatment plants along the Valley’s east-west axis. However, poor infrastructure continued to pose a public health risk. As pollution worsened, the municipality and the State Hydraulic Works (*DSİ*) paved the streambed with cement and stone, permanently altering the surrounding ecosystem (Figures 11b and 11c). Thus, natural riverbeds were replaced by narrow river corridors and tunnels of artificial materials, rendering the original boundaries of this watercourse no longer discernible.

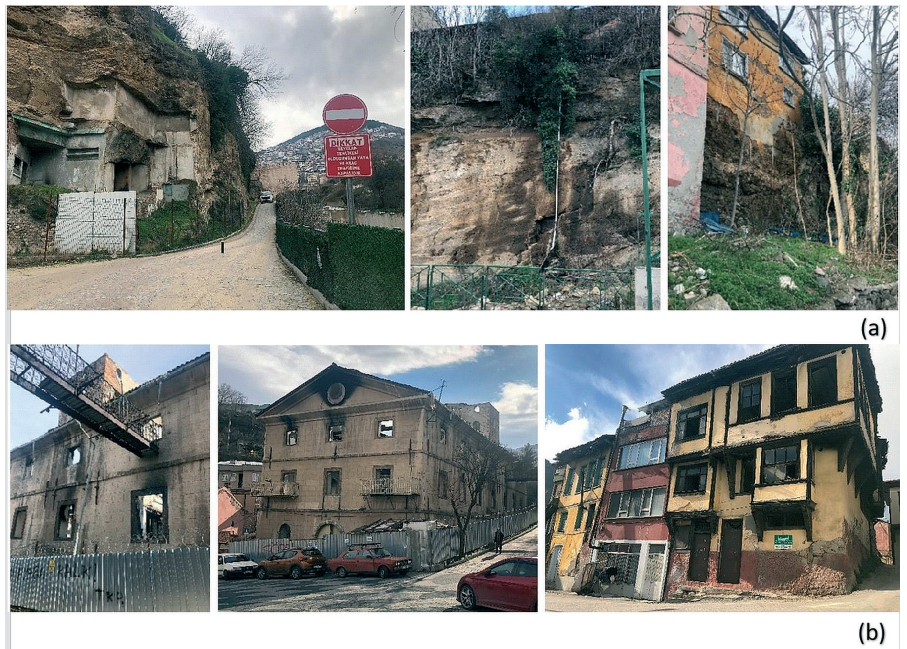
**Figure 12.** (a) Facade deterioration and structural cracks on the citadel walls and travertine cliffs in the study area; (b) Abandoned and vandalized industrial buildings (Photos by S. Çakıcı Alp).

The municipal archaeologist committee reported that the remains of the Citadel walls, partially destroyed by natural disasters and vandalism, pose a public safety risk and require urgent repair in 2007 (12). It is particularly emphasized that the consolidation of partially collapsed citadel walls should be preferred instead of reconstruction. However, the southwest corner of the Citadel's walls, between the Zindankapı and Yerkapı gates, was reconstructed by using modern building materials. While such a reconstruction approach remains debated in both national and international conservation contexts, it raises a serious concern, in which rebuilding without adequate scientific evidence has the potential to

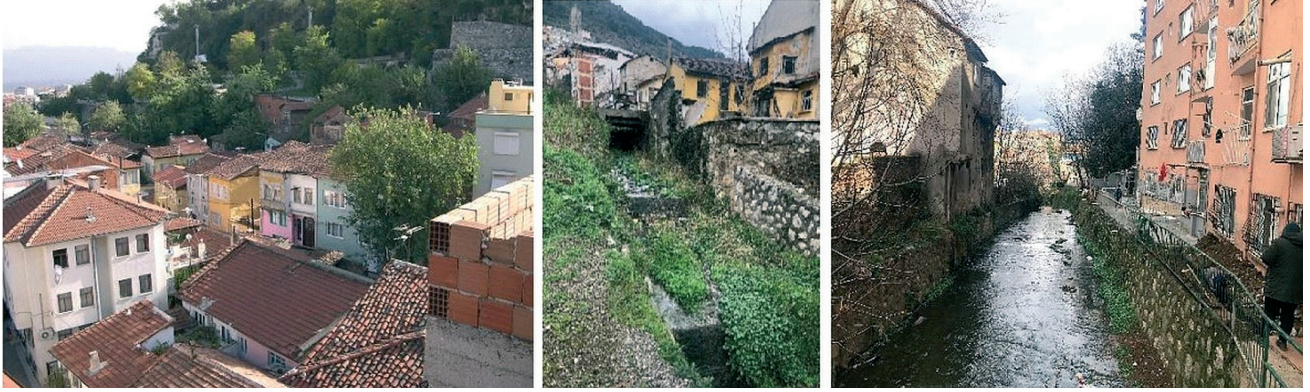
**Figure 13.** Irregular urbanization and squatter housing units within the Cilimboz Valley (Photos by S. Çakıcı Alp).

mobility has emerged in the study area due to the uncontrolled increase of illegal and irregular construction towards the slopes of Uludağ (**Figure 13**).

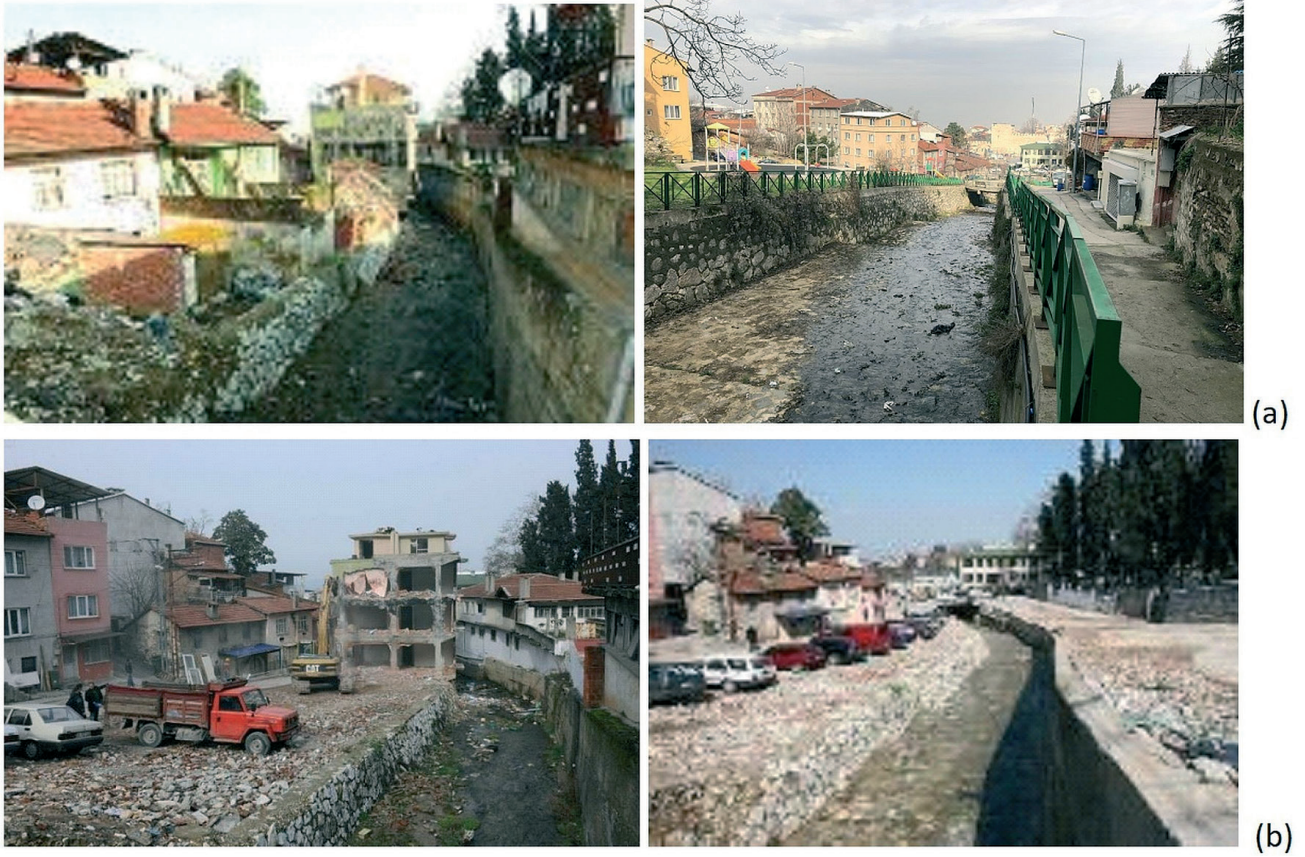
Figure 14. Before (a) and after (b) the rehabilitation process along the Cilimboz Valley due to the flood in 2010 (Bursa Metropolitan Municipality, 2024).

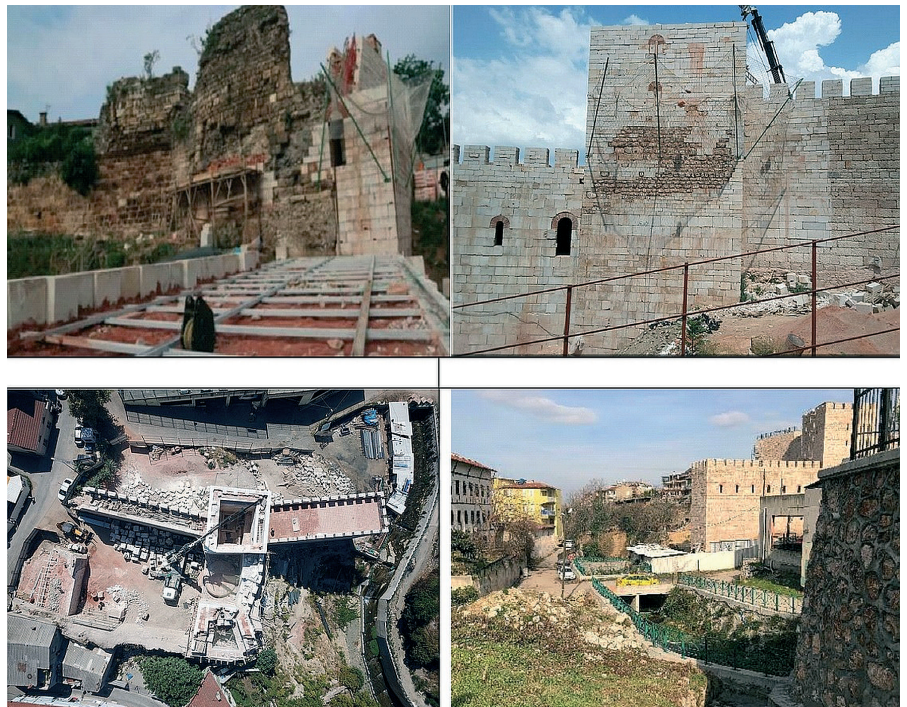
Figure 15. The reconstruction process of the historic Citadel walls (Photos by S. Çakıcı Alp).

create various problems in the future (Figure 15). Moreover, contradictions between ancient and modern structures create replicas that conflict with the authenticity and sense of belonging. In brief, both the natural disasters
