## THE RESTITUTION PROCESS IN CONSERVATION: DISCOVERING THE HISTORY OF ŞEHİT ALİ PAŞA LIBRARY (1)

**Keywords:** 18<sup>th</sup> century Ottoman Architecture | Şehit Ali Paşa Library | Ottoman Libraries | construction technique | restitution.

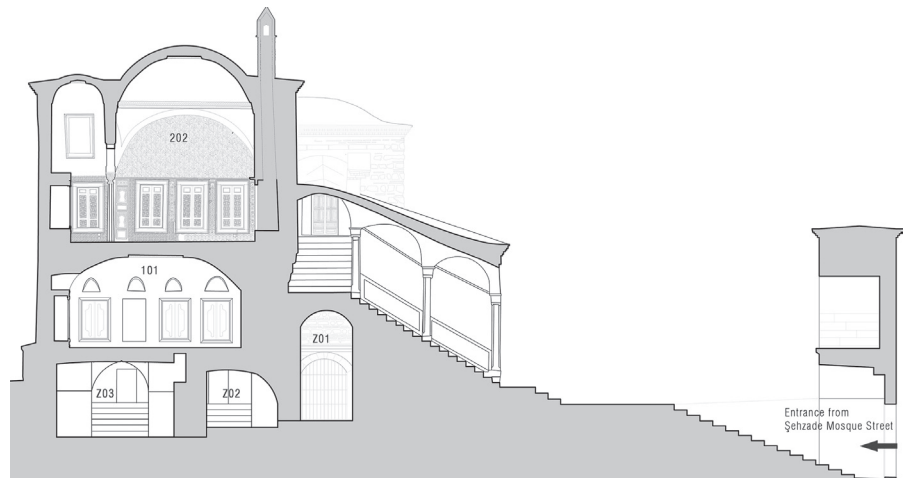
Figure 7. Sehit Ali Pasa Library Section-1, 2012.

Şehit Ali Paşa Library is currently located in the courtyard of Vefa High School in Istanbul and was used as storage of the school for a while. So, the entrance is under control of the school management and after KADEM Foundation (4) has rent the building, it is also accessible from the gate on the Şehzadebaşı Mosque Street. The entrance is reached by passing through one of the vaults of the Valens Aqueduct. The garden wall is quite gorgeous to be a garden wall; there are two storeys of huge arches, which strengthen the theory that it was a part of the aqueduct (Figure 6a). The marble inscription is above the gate (Figure 6b), and the stairs starting from this door lead to the ground floor of the building. The library consists of two main blocks connecting at the second floor. The library was built as ground floor and two floors; there is a middle landing reaching the first floor, and afterwards, the staircase covered by a vault, is leading up to the second floor (Figure 7).

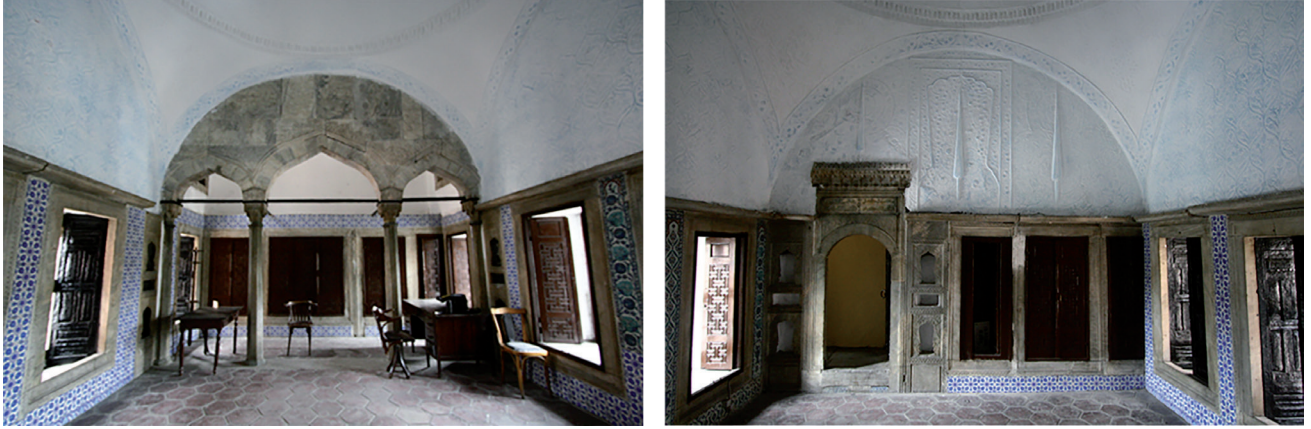
Figure 9. Main Reading Hall, 2012.

The L shaped staircase covered by a vault on the northwest façade leads to the second floor where the main spaces are located. *Küfeki* (7) columns and brick arches are supporting the vault, which stuck to the façade with an iron bar. The staircase leads to the space 201 closed by the original iron cast door. Two columns, which are typically same as the ones at the staircase, are embedded both sides of the door. The main space of the library is reading room where also the books were stored, is named as 202 (Figure 8c), and is connected to the room 201 with a short and narrow corridor enclosed by two original iron cast doors. This space is the most glorious space of the building in terms of spatiality, variety in use of materials, ornamentation and decorative elements (Figure 9). The space was divided into two parts with marble columns with stalactite capitals and three pointed arches between them. The main square hall is covered with dome, and pendants are used as transition elements. Both of pendants and dome are ornamented with plaster as used *malakari* (8) technique. On the other

hand, the rectangular part of the space is covered by cavetto vault with *şemse* and *Türk üçgeni* ornamentation around it. Furthermore, there are two upper windows at the rectangular shaped secondary part of the space, only can be seen from the interior. On the southeast and northwest walls of the space, six wide niches with *kündekari* (9) wooden shutters are embedded, which are considered as book storage spaces. Two types of glazed tiles are used on wall surfaces. The variety of those glazed tiles are most probably because of later interventions. However, this wealthy room in terms of spatial organization, architectural characteristic and ornamentation, clearly shows the structural problems, physical deteriorations, later interventions and the clues of previous phases of the building. Besides, on the northeast

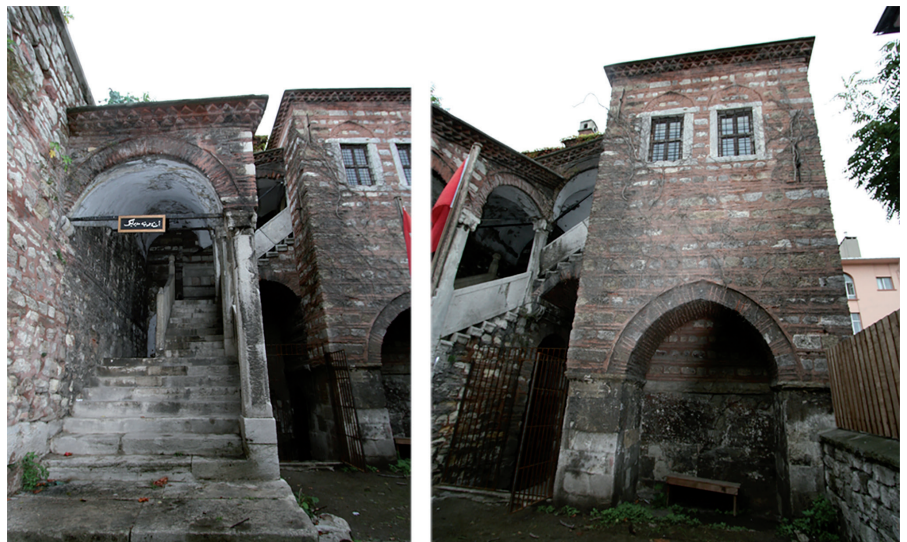
Figure 12. The Northwest Façade, 2012.

After arriving at the garden from the gate on the Şehzade Mosque Street, northwest façade of the library is firstly seen (Figure 12). Three types of masonry are observed on this façade. The prevalent wall type is Type C, which is common for two blocks; Type B is observed in the lower parts; and the other wall masonry type is Type F that can be seen from the staircase stuck to the northwest façade of the main reading hall (Figure 13). For some reason, this wall looks like as ornamental wall and the pattern of this part is different from the rest. There are rounded limestone blocks, which rise from the wall and the staircase is stuck in this wall, which is very contradictory situation. Because, it is not a common thing to put a staircase in front of this kind of ornamental wall in the first planning. Therefore, it is possible to claim that the staircase was added later than the first construction in the past, but not very close to today. Another important detail should be mentioned is an arch and a niche at the lower side of the front block; Type A masonry is detected and inside the niche, there are two

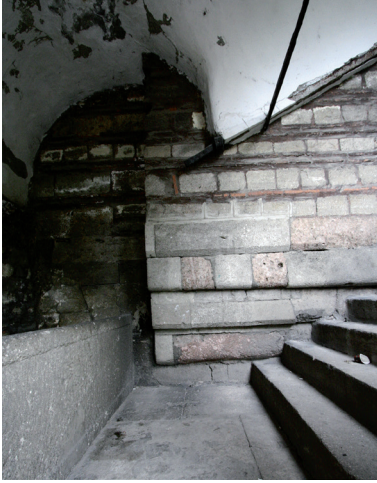
Figure 13. Northwest Façade, Type F Wall Masonry View from Staircase, 2012.

that the staircase was built at the first phase of the building (Figure 13). Another situation supporting the idea that the staircase is a later addition is the relationship between the landing and the arched door of the space named as 101 (Figure 25). Obviously, if the staircase were originated in the first phase, it would not have been fixed to the arch as in the current situation. To conclude, this staircase is a problematic architectural element considering its physical relation with the building, vault formation, and circulation planning.

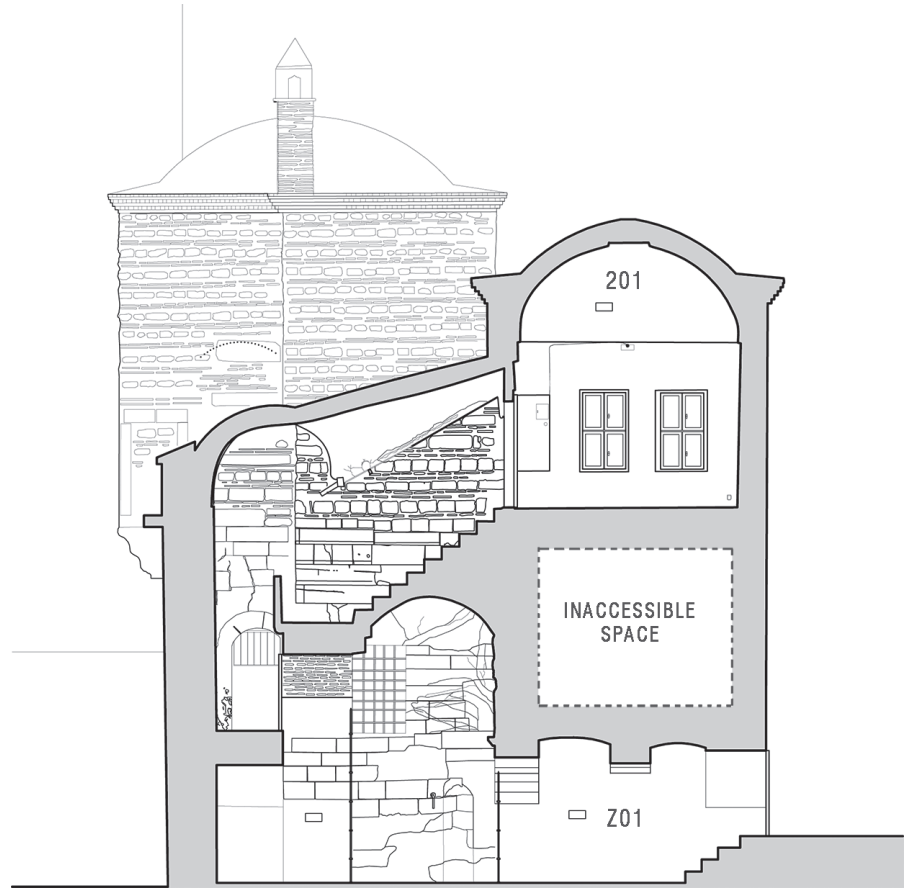
Figure 14. Şehit Ali Paşa Library Section-2, 2012.

arches and a fountain hole, which does not work today. Above the niche, there is an inaccessible space, which is quite stimulating to consider (Figure 14). The functional theory of this space will be discussed in the third section.

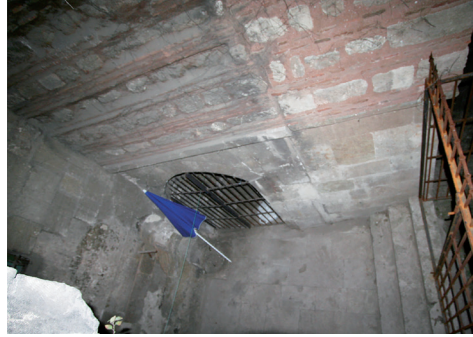
Figure 16. Southwest Façade, 2012.

On the southwest façade of the library, three types of masonry are observed; Type B, Type C and Type D (Figure 16). Mainly, limestone blocks are used in construction of the lower part of this façade, but the southeast corner of the smaller block, there is an area constructed in Type C, which is considered as an intervention in the past. According to the photographs dated 1971, this building was repaired and the cement part, which was an inappropriate intervention in the past, was replaced the original fabric the decision of Directorate of Foundation (Figure 17b). Alternating wall masonry of southwest façade consists of two rows of brick and a row of stone. The lower part of the main reading hall, there are two types of material; limestone and *Od Taşı*, which is known its resistance to fire. Thus, it would be a repair as a result of a fire as indicated in the inscription. Besides, there are six windows and a dovecot with limestone edges on this facade and five of the windows have limestone window frames in spite of one of them has *Od Taşı* window frame, which probably could be replaced during a repair in the past. In addition, above the windows on the smaller block, there are brick-filled relieving arches and three rows of brick and cut stone blocks are placed on the upper parts of the main reading hall (Figure 16).

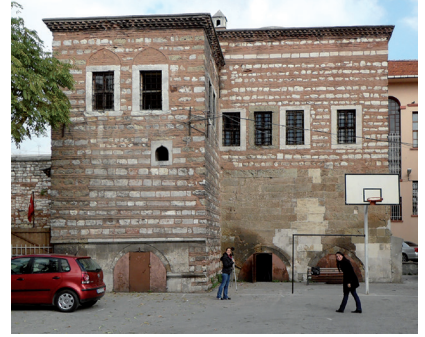
Figure 17. (a) Northeast Garden Wall of the Library, (b) Southwest Façade, Terracotta Water Pipes in the Wall 1971 (Directorate of Foundation Archives, 1971)

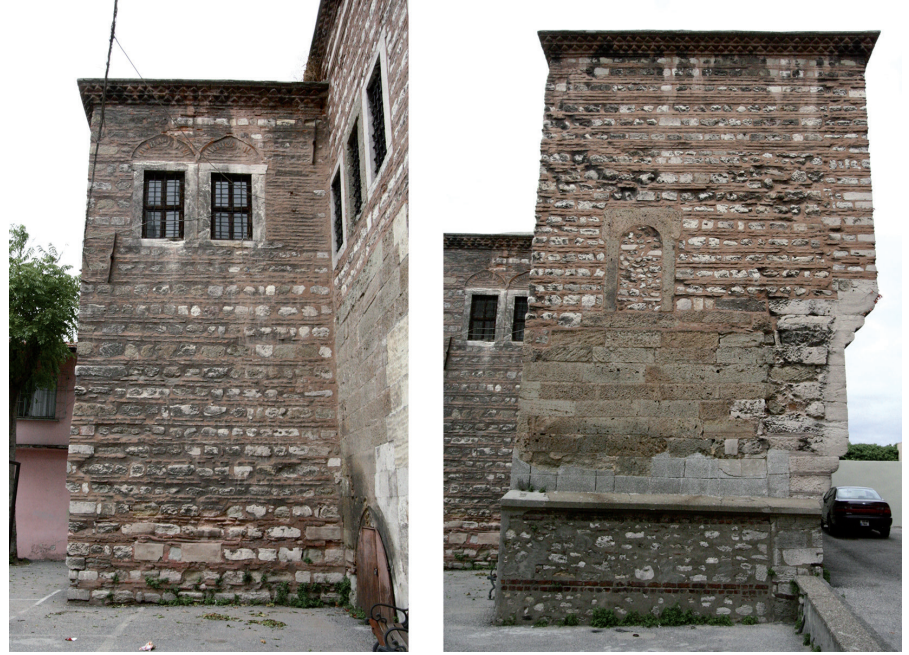
Figure 18. Southeast Façade, 2012.

Type B, Type C, Type D and Type E wall masonry types are observed on the southeast façade. The larger block was completely built in alternating wall masonry. Besides, there are two windows with limestone window frames and above them there are brick-filled relieving arches. On the upper part of this wall, partial brick masonry wall is seen, which is most probably a partial repair (Figure 18). The lower part of the wall is built in rubble stone masonry with cement mortar, which indicated that this part of the wall is more recent than the upper parts; in the middle part of the wall is Type D. The northeast corner of the façade, there are limestone blocks and the ornamental stone profiles are quite distinguishable from that view. Above Type D masonry part, a door case, which was filled with brick and stone, is considered as a clue for the restitution proposals.

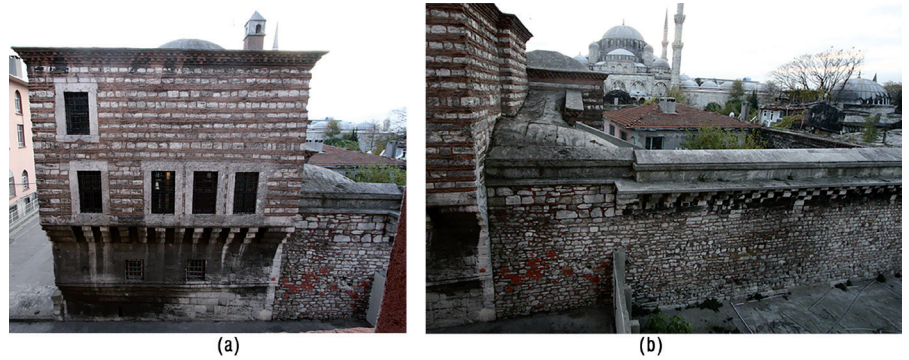
Figure 19. (a) Northeast Façade, (b) Garden Wall and Load-Bearer Stone Projections, 2012.

The northeast façade of the library is the most spectacular one in compared to the other façades; because there are load-bearing ornamental stone elements starting from the southeast corner to the end of the garden wall (Figure 19a), (Figure 19b). The northeast façade consists of two types of masonry; Type B and Type C. The basement and the first floor of the library were constructed in cut stone masonry with limestone blocks and at the bottom of the windows, rounded stone profiles are observed. Second floor wall was built in Type C, alternating wall masonry, and there are five windows with limestone window frames. The projection of the second floor is carried by the load-bearing stone elements. The wall between the north corner of the library and the point that the stone profiles of the garden wall start was demolished in the past and was repaired in 1970s. However, there is something different in the wall fabric, which will be explained in the following section.

with the garden wall intersecting the other wall as a part of Süleymaniye Aqueduct (**Figure 19b**). The projections, are built for structural reasons as a load-bearer element, but also have aesthetical concerns. Therefore, continuity of the stone projections for just aesthetical reasons is not logical. It could be considered as a substructure for a building, but any proposals were not submitted in the restitution to avoid assumption due to finding no evidence or document about it. Only, documents obtained in research process for these projections tell that the garden wall was collapsed and it was repaired according to the records of Directorate of Foundations (**Figure 17a**). On the other hand, after the survey, the trace of an arch was exposed due to the leaf cast in fall. This arch could be seen from the photographs dated 1971 in the archive of Directorate of Foundations. Interestingly, this arch is very close to the upper level of the vault covering the staircase. It can be interpreted as there was an opening, a window or a door on the northwest façade and it was filled with brick and stone in the past and the staircase and vault were built afterwards. Going back to the projections, there is a gap between the projections where the building ends at the northwest corner. In this part of the garden wall, the texture is different from the rest and this difference can be seen in the photographs dated 1971. It means that there was a repair or change in the past considering the façade characteristic, and the situation of the entrance gate in the northwest garden wall on the Şehzadebaşı Street is suspicious. As noted by Şahin (2009a), the street façade was emphasized with projections and had wide windows in the 18<sup>th</sup> century Ottoman libraries. If this façade was designated as the main façade of the library, it is claimed that the entrance gate has been located on the northeast garden wall and removed at an unknown time in the past.

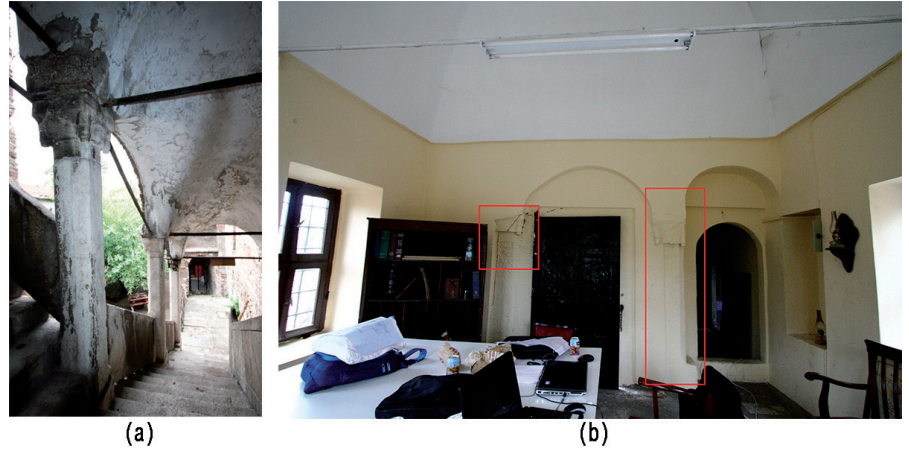
Figure 24. (a) The Columns at the Staircase, 2012. (b) The Columns Embedded in the Northeast Wall of the Room 201, 2012.

claim that the basement floor was open in the past. However, there are no documents, maps or photographs showing this previous condition of the building in the archives or publications. Furthermore, Küçükalfa (1984) states that the entrance hall (201) of the main reading room was an open sofa such as Halet Efendi and Hekimoğlu Ali Paşa Libraries, which were built in 18<sup>th</sup> century. Considering their construction dates, they could be built similar to each other as a result of representing the typology of that period. As emphasized, the columns and capitals at the staircase on the northwest façade are typically same as the columns embedded in the northeast wall of the room 201 (Figure 24a), (Figure 24b). Therefore, it can be claimed that the space was an open sofa, but it was closed afterwards for some reason by filling between the columns with stone and brick and removed some of the columns to build the staircase. This claim brings new discussions, but before that, the staircase should be examined in detail. The L shaped staircase sticks to the northwest façade of the library. However, behind the staircase, at the second floor level, three courses of rounded stone profiles are projecting from the façade and it does not make sense

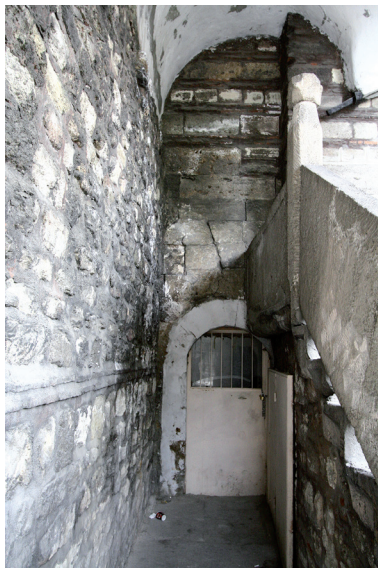
Figure 25. Relationship Between the Staircase and the Arched Door, 2012.

Apart from the staircase, the variety of the stone forms and types or the number of brick rows are remarkable. Apparently, this building has past interventions through the northwest façade and the others also. Going back to the emerging questions based on the uniformity of the columns and capitals at the staircase and 201, theoretically, the period of closing the open sofa and the construction of the staircase could be same. Nevertheless, if the staircase is a later addition, obviously it is, how would the people reach to the second floor and reading room? It is still a mystery for today due to lack of information and document about the origin of the building and the later interventions. However, it is possible to generate some theories about situation before the construction of the current staircase.
