## THE NEIGHBOURHOOD MOSQUE WITH WOODEN MINARET IN BOSNIA AND HERZEGOVINA FROM 16<sup>th</sup> AND 17<sup>th</sup> CENTURY: FOUR EXAMPLES OF RESTORATION IN TUZLA REGION

**Keywords:** Mosque with wooden minaret; Džindijska Mosque; Mejdanska Mosque; Atik Mosque in Čive; Džebarska Mosque.

This study analyses four neighbourhood mosques in northeast Bosnia and Herzegovina dating back to the 16<sup>th</sup> and 17<sup>th</sup> century, which have been restored in last few decades. It is assumed that they possess authentic characteristics, which impose the importance of preserving this segment of the built heritage in Bosnia and Herzegovina. The condition before and after the restoration is also assessed. They are also compared with several matching examples from different places in Bosnia and Herzegovina.

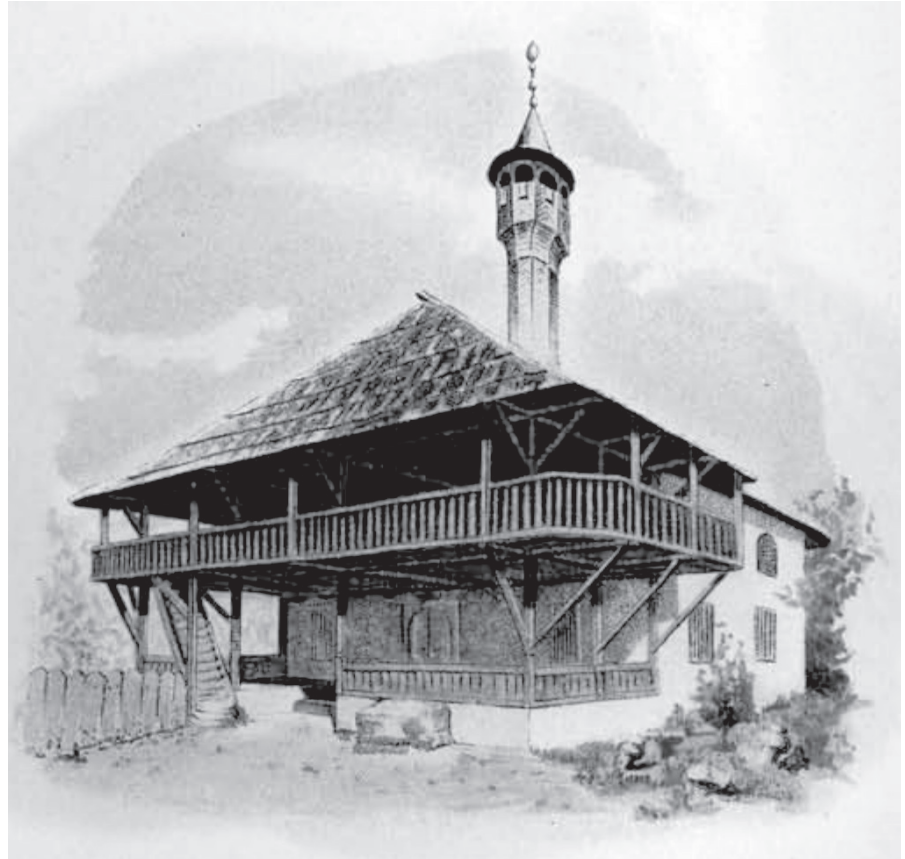
**Figure 2.** The Džindijska Mosque according to Meringer (1899) (Watercolour painting by Simić)

The mosque was built in the Džindijska neighbourhood (*mahalle*) in Tuzla town, which had been developed shortly before the end of 16<sup>th</sup> century (Handžić, 1975, 186) by Mustafa Džindija (10). It is assumed that he founded a mosque as well. However, the mosque was mentioned in 1701 under the name of a certain Husein Čauš, who probably renewed it (Handžić, 1975, 186). The mosque was erected at the crossing of roads from which the main one led directly into one of the four main gates of fortified *kasaba*. The oldest known record of its appearance was made at the very end of the 19<sup>th</sup> century. In his brochure from 1899, Rudolf Meringer (1899, 237) brought water colour paintings with plans of several neighbourhood mosques in Tuzla. The image of the Džindijska Mosque shows wide gallery in the porch that is extended on three sides. Both gallery and roof eaves are supported by short bracing beams (*čusteci*) (11) (Figure 2).

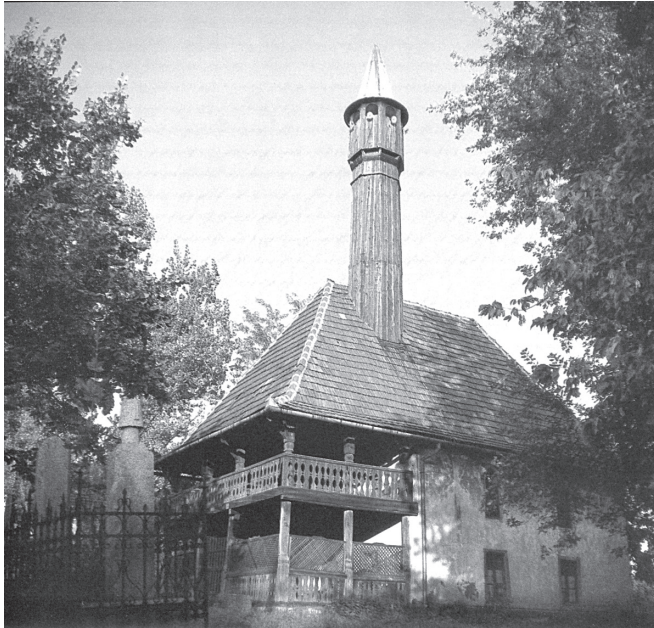
**Figure 3.** The Džindijska Mosque Before Restoration 1982 (IGRO Univerzal, Photo Monography of Tuzla, 1983)

However, the image of the mosque taken before 1982 (Figure 3), clearly shows changes made in the meantime. The building seemed fairly deteriorated, with no extensions of the exterior gallery, and with the roof covered with clay tiles. Still, some details of decorative carving on the timber posts were visible. Thanks to the initiative of several conscious individuals in Tuzla, this valuable example of vernacular Bosnian

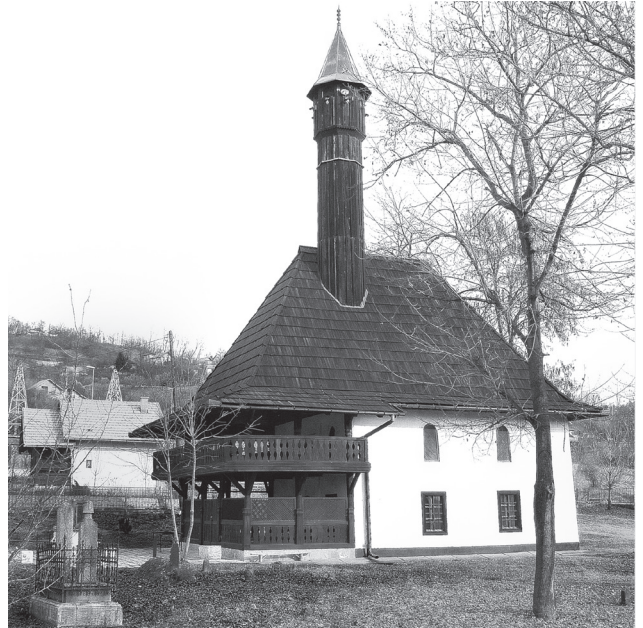
**Figure 4.** The Džindijska Mosque 2004 (Courtesy of M. Terzić)

architecture has been saved from the final disappearance (12). The building was completely restored, except mud brick walls which were reinforced and newly rendered (13). In addition, the roof was renewed with original roofing material, wood shakes (Figure 4). Almost twenty years later, deteriorated shake has been replaced by a plain board (*šimla*). The current condition of the roofing cover is very bad and requires immediate replacement.

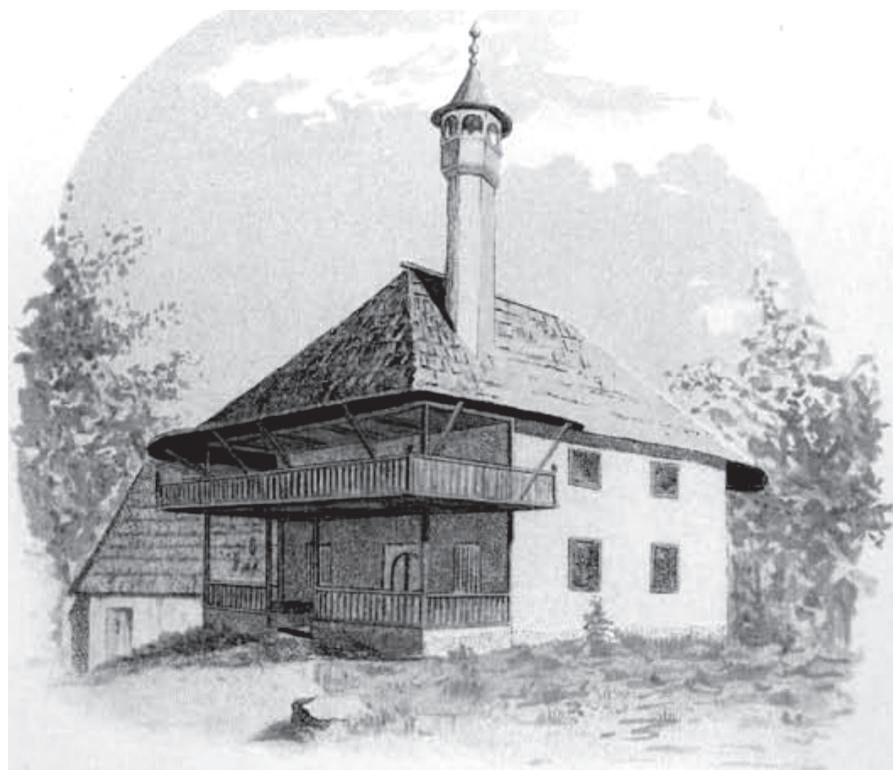
**Figure 6.** The Mejdanska Mosque according to Meringer (1899) (Watercolour Painting by Simić)

A certain Dželāli Vāiz Mehmed-Efendi founded a masjid in Donja Tuzla before 1644, where he performed the duty of imam until 1664 (Handžić, 1975, 188). Later on, the masjid was mentioned as Vāiz Ali-Efendi Mosque in Dželāli or Mejdān neighbourhood (*mahalle*) in Donja Tuzla town (Handžić, 1975, 188). Today, it is known as the Mejdanska (*Meydan*) Mosque. Its location shows typical position of the mosque in the *mahalle* development during the Ottoman period. The mosque is situated near the crossing of two streets, on the triangular sloping site together with adjacent *Sibyan Mekteb*. As is the case of the Džindijska, the oldest recorded appearance was available through Meringer's brochure (1899, 237). The image shows a mosque with two-story porch with extended gallery, four windows on southwest side, and a roof covered with shakes (**Figure 6**). At the first glance it resembles the Džindijska Mosque.

Unlike the Džindijska Mosque with both internal and external stairs, the Mejdanska Mosque currently includes stairs within the prayer room. As in previous cases, according to an old floor plan drawing, it is quite clear that there were additional external stairs to climb up to the gallery (**Figure 6**) (**Figure 9**). There is no information when and why those stairs had been removed. This may have happened in the first half of the 20<sup>th</sup> century, when the porch gallery had been removed too. Comparing to Tuzla's mosques, the Atik and the Džebarska Mosque have no stairs inside the prayer room. The access to the *mahfil* is obtained by means of a door in the wall above the main entrance.

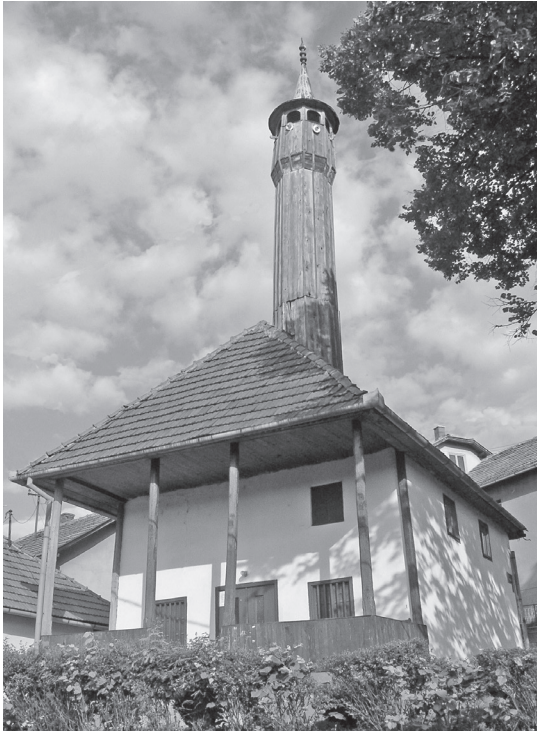
Figure 7. The Mejdanska Mosque before 2005 (Photo by E. Jahić)

As many other mosques in Bosnia and Herzegovina, it lost the original look during some of previous interventions, the most likely at the beginning of the 20<sup>th</sup> century (**Figure 7**). The building had six plain timber posts rising from the porch and supporting the front part of the roof. Instead of shakes,

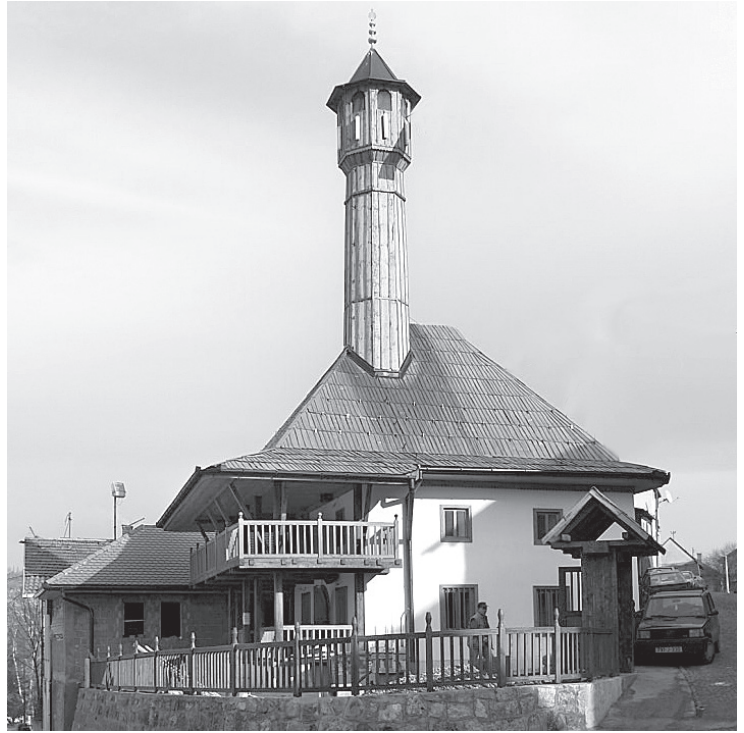
Figure 8. The Mejdanska Mosque after restoration (Courtesy of M. Terzić)

the roof had been covered with clay tiles. Since some of lower windows had been walled in, the interior looked pretty dull. As in the case of the Džindijska, the image brought by Meringer (1899), was pretty helpful in the last renovation in 2005 (14). The timber elements were restored in a quite correct manner (Figure 8). Only massive walls were kept and refurbished. The roof was covered with wood shakes, however, due to a low quality, the roofing material did not last as it was planned.

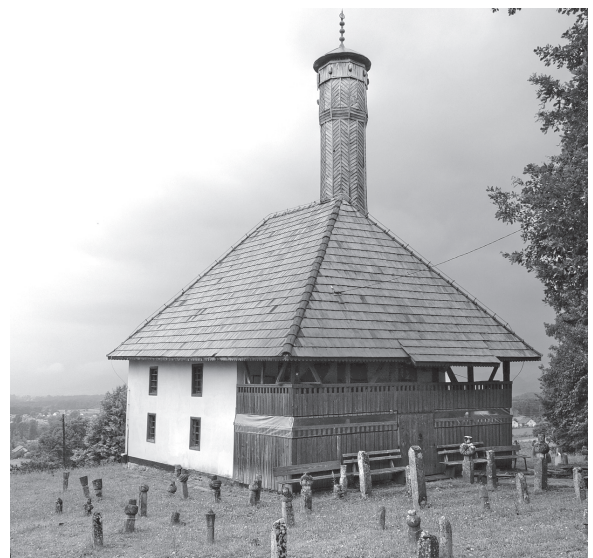
Figure 11. The Atik Mosque today (Photo by E. Jahić)

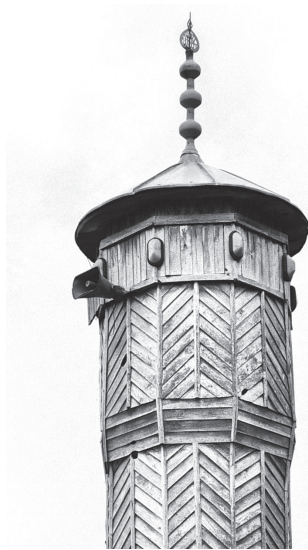
Figure 12. The Minaret of the Atik Mosque  
(Photo by E. Jahić)

As is the case with previous samples, no data on an earlier appearance of this building could be reached. Prior to its last restoration, the Atik Mosque seemed fairly time-worn, with the porch closed on with brick (15). The mosque was restored by the local community with the service of a skilled architect, in period of 1991, and then in 1998–1999. Timber elements were refurbished or completely replaced (Figure 10). Despite the lack of information on the mosque's earlier appearance, the architect succeeded to restore the most suitable look. Instead of original shakes, the roof is clad again with flat clay tiles. Brick walls in the porch are demolished and the wooden fence is made of tall plain boards, what seems quite suitable because of the remote location of the building (Figure 11). The wooden minaret is completely restored with a new material. It has a polygonal sixteen sided shaft 1,3 m wide. The sharafa is octagonal and it has small openings with wooden cases. Both minaret shaft and sharafa are clad with battens in a traditional herringbone pattern (*šašavci*) (Figure 12) (16). There is a low slope conical roof at the top, covered with sheet metal.

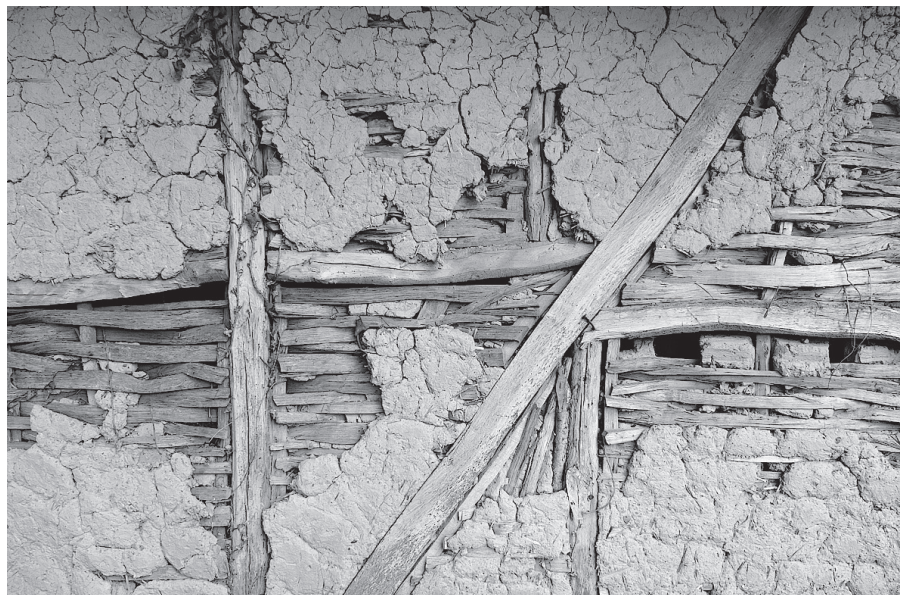
Figure 14. Wattle-and-daub remains in the vicinity of the Atik Mosque (Photo by E. Jahić)

probably plastered and whitewashed wattle-and-daub, which has long since gone. This construction method is still visible in a few older houses in the vicinity of the mosque (Figure 14). The timber frame beams are fixed in a way as to accommodate sixteen windows in two levels on four sides, measuring 65×85 cm. Lower windows are secured with a simple rectangular iron grid (*demir*).

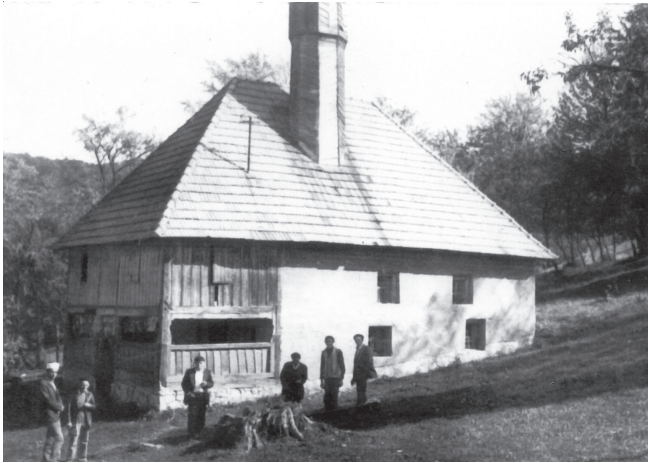
**Figure 15.** The Džebarska Mosque in the first half of the 20<sup>th</sup> century (Photo by unknown author)

The basis of the latest restoration was a sketch of unknown author, brought by Suljkić (Ibni Hasan, 1985), as well as the photo dating back to the mid-20<sup>th</sup> century (Figure 15). Both images clearly show that the mosque have a high wooden curtain enclosing the porch. The Džebarska Mosque was restored in 2005 by the local community with a service of a skilled architect. Before the restoration, the porch was, as in the previous case, walled up (Figure 16). Both beams of the roof structure and other timber elements seemed worn-out. There were also several visible cracks in the rubble walls, probably because of a shallow foundation on the sloped terrain. The mosque was completely restored, except rubble walls which were reinforced and newly rendered. The wooden veranda, the roof and minaret, were rebuilt according to available images (Figure 17). Interior elements were refurbished and reinstalled back, or eventually rebuilt where it was necessary.

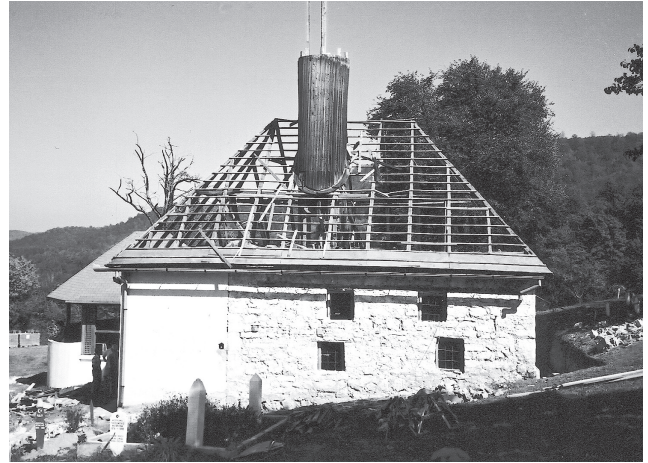
**Figure 16.** The Džebarska Mosque at the beginning of restoration works in 2005 (Photo by E. Jahić)

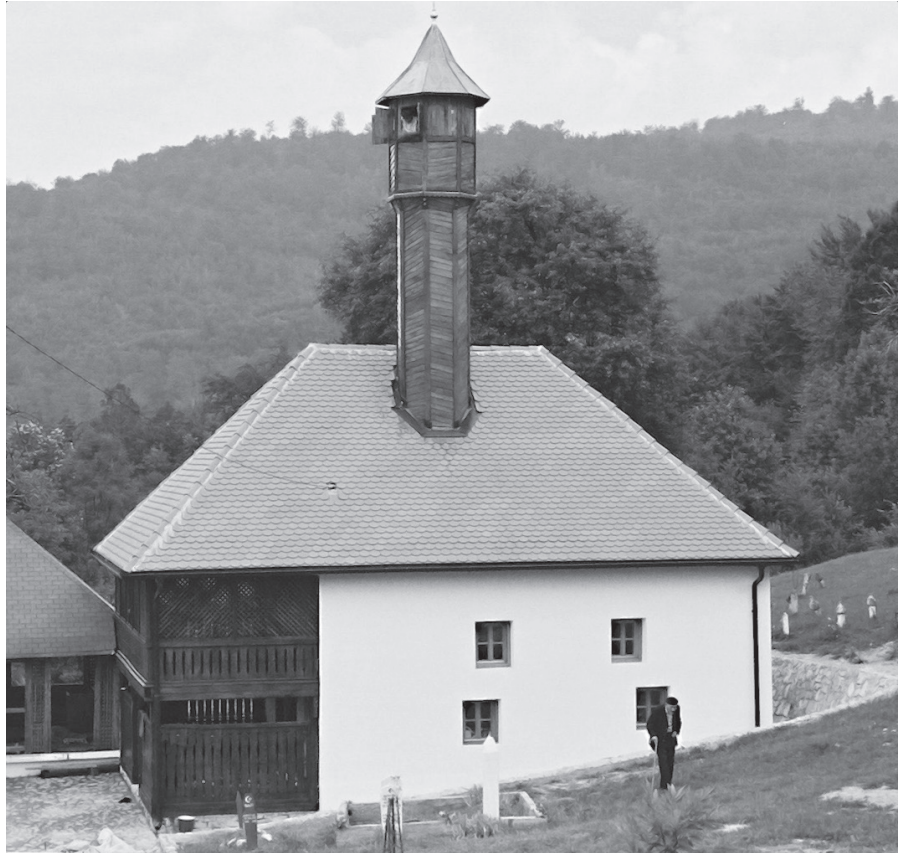
Figure 17. The Džebarska Mosque after the restoration in 2006 (Photo by E. Jahić)

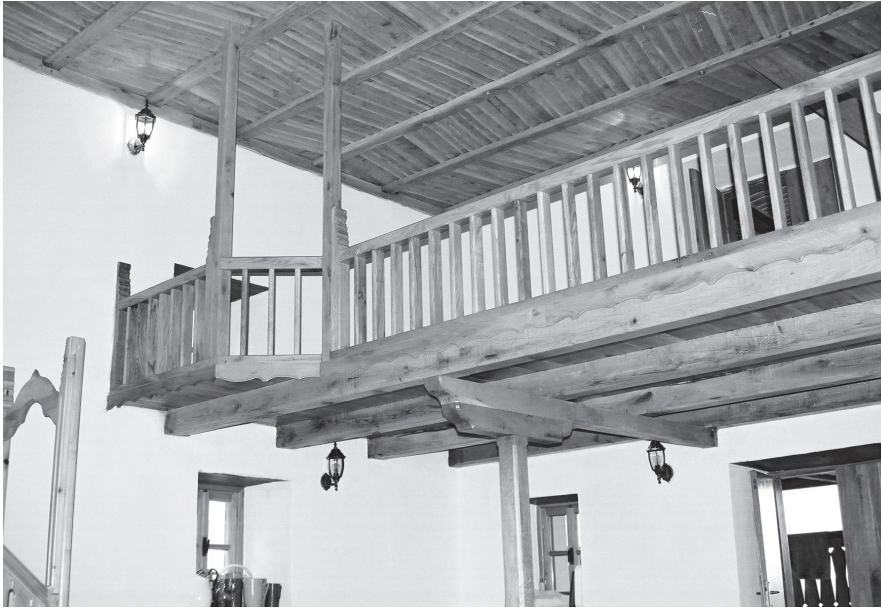
**Figure 19.** View of *Mahfil* in the Džebarska Mosque (Photo by E. Jahić)

The Džebarska Mosque measures approximately 12×8 m externally, and consists of a prayer room 7×6,2 m inside and two-story porch 3,3 m deep (Figure 18). The walls of the prayer room were built of local rubble, unequal in size and irregular in shape. They are nearly 90 cm thick, all strengthened with oak *hatule*, and plastered and whitewashed both inside and outside. Two lateral walls are pierced with four rectangular and quite small windows, except *qibla* side with two high windows, and entrance wall with two lower windows. The mihrab is simple semi-circular niche with no portal or decoration. The ceiling consists of oak beams and battens inserted in herringbone pattern into side grooves of the beams. The hand-made traditional woodworking of ceiling beams and *šašavci*, as well as the refurbishment of the deteriorated *mahfil* beams, were done by the local master (Figure 19).

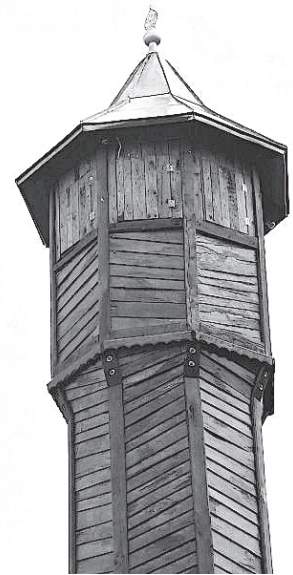
**Figure 20.** The Minaret of the Džebarska Mosque after the restoration (Photo by E. Jahić)

The unique hip roof covers the mosque and the porch. It is assumed it was originally covered with shakes which were subsequently replaced by the clay tiles. Following the latest condition, the local community asked for new tiles again during the last restoration. The peculiarity of the mosque is also visible in the minaret. In comparison to many examples, the minaret stands almost exactly in the middle of the long side of the roof. Its shaft consists of eight grooved oak poles with slantwise inserted *šašavci*. It is finished with a slightly wider *sharafa* having small openings with cases at each side (Figure 20).
